# City of Carlsbad Wildlife Movement Analysis Final Report

Local Assistance Grant Agreement No.  
P1282107

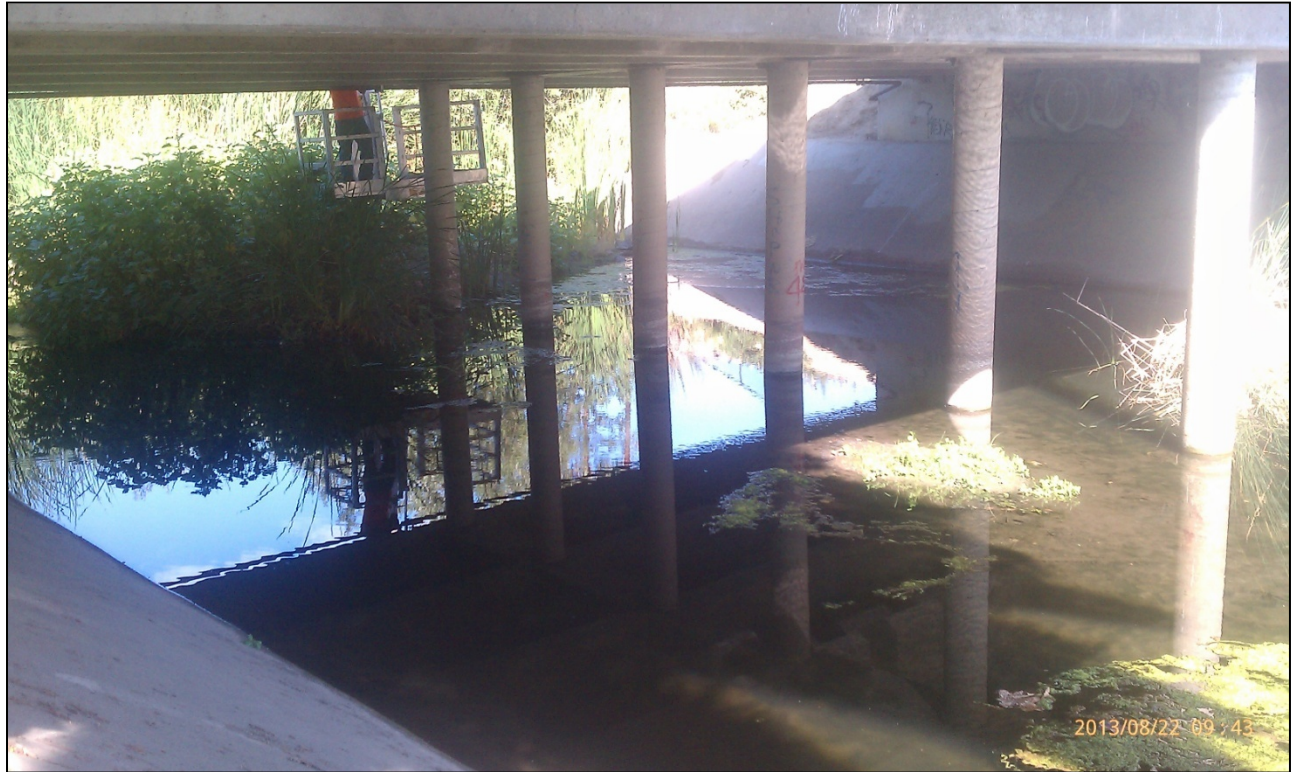
EW1-4, looking underneath from SE entrance, August 2013

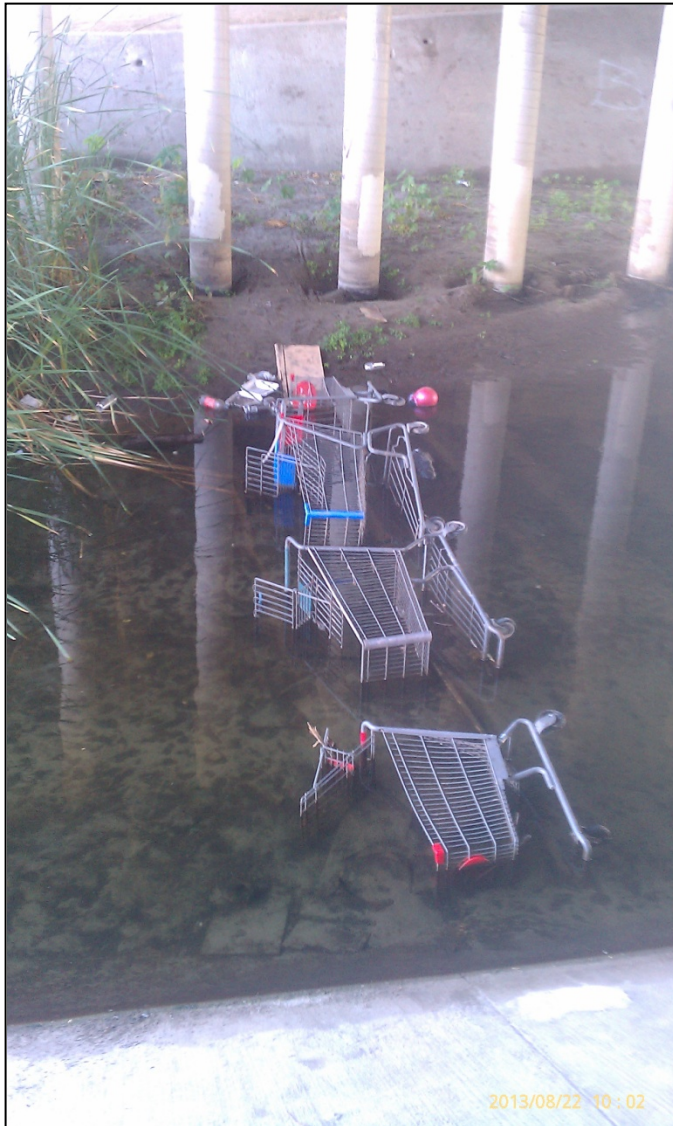
EW1-5, interior showing human impacts, August 2013.

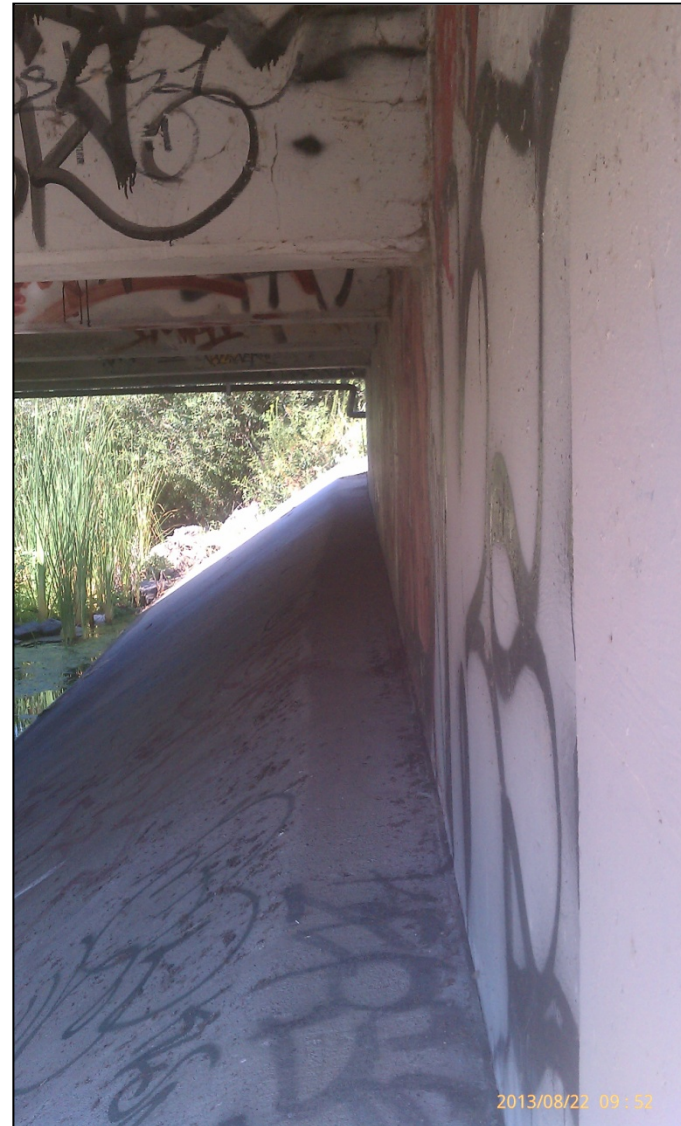
EW1-5, looking east on south side, August 2013

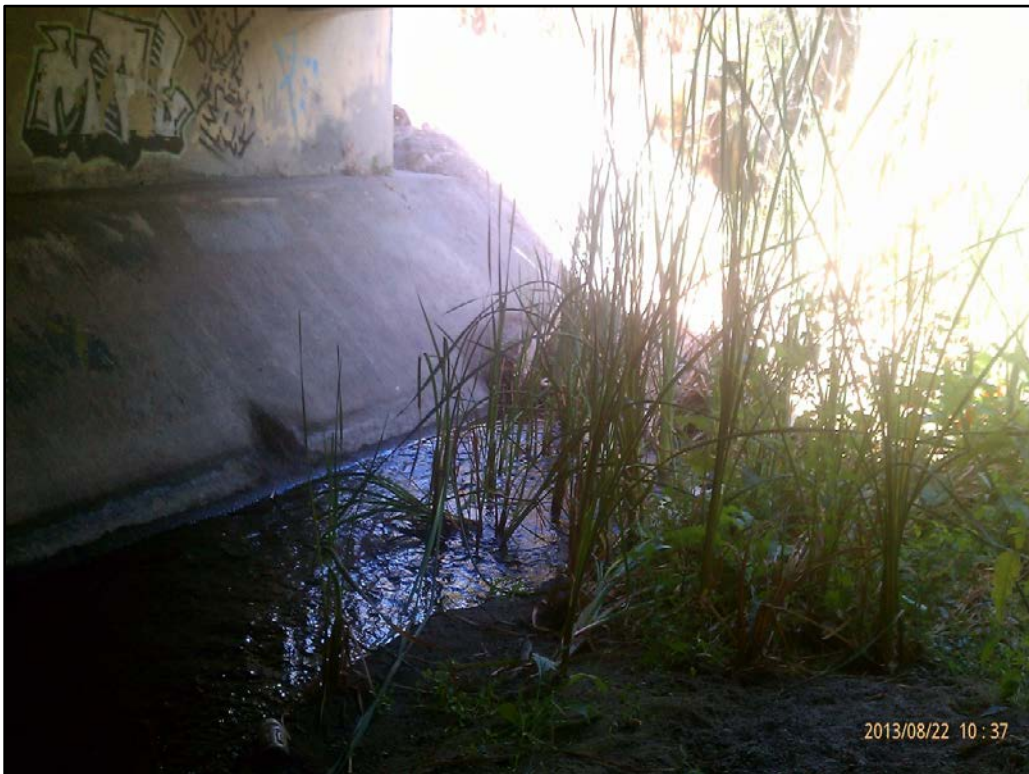
EW1-6, looking north from west entrance, August 2013.

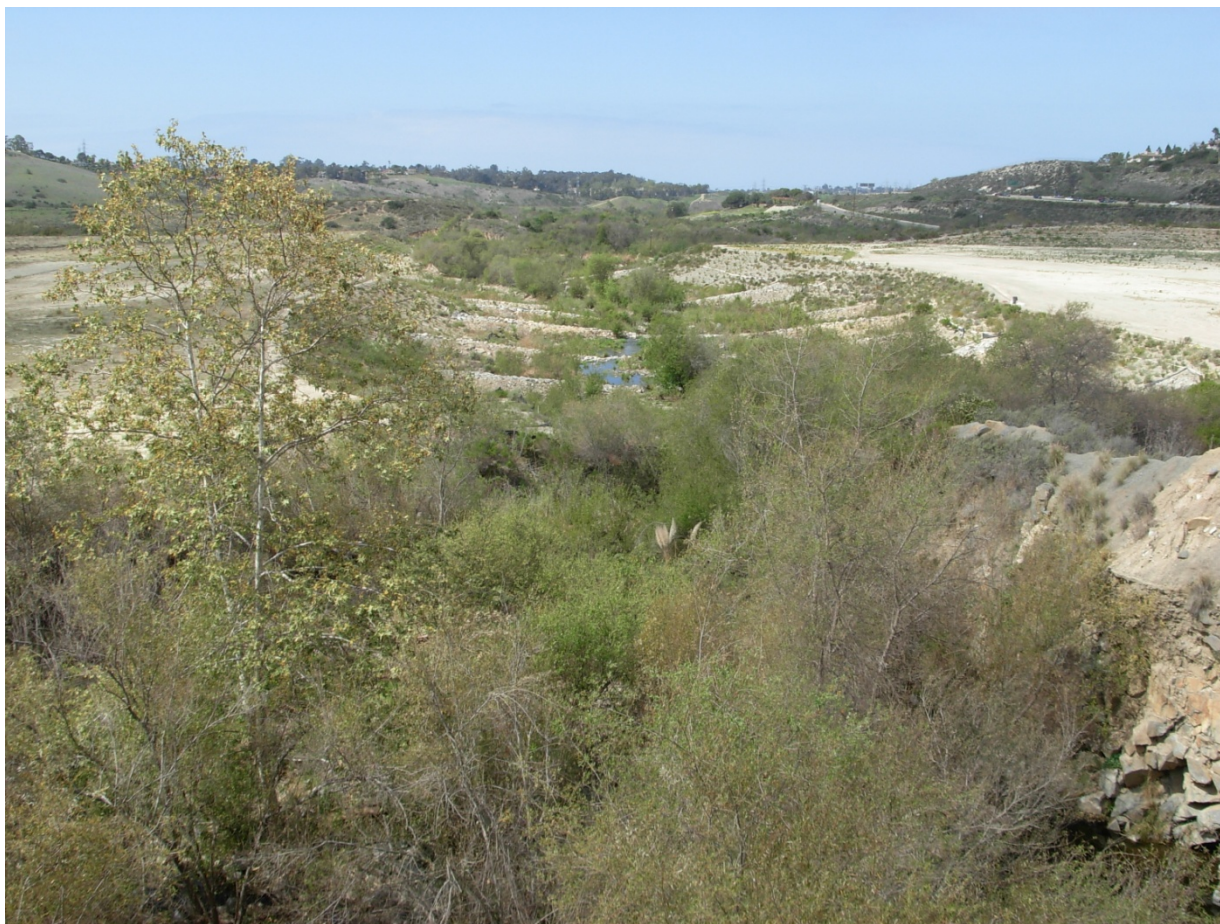
EW1-7, looking west from adjacent developed property in Oceanside.

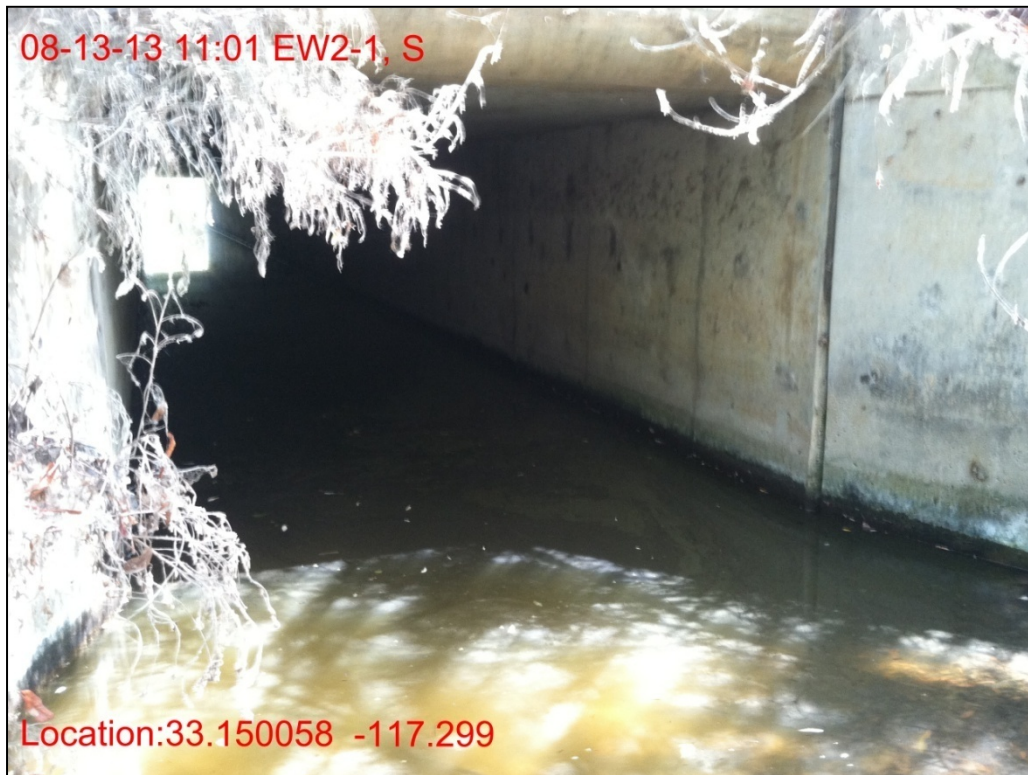
Regarding possible Task 2 monitoring, no further camera work is likely needed at EW 2-3 and EW 2-9 because the previous CNLM camera surveys proved that many different species successfully use these undercrossings. EW2-1 is a permanently wet undercrossing and not recommended for future monitoring. Due to the lack of restrictions, EW2-2 in the Calavera Hills/Robertson Ranch preserve, and EW2-6, EW2-7, EW2-8a, and EW2-8b in and around the Rancho Carlsbad Golf Club, may be suitable for camera and/or tracking to document the species using this portion of the corridors, provided resources are available. Pinchpoints EW2-4, EW2-5a, and EW2-10 could provide opportunities for camera and/or tracking monitoring due to their importance and dispersed locations along the corridor.

EW2-1, southern entrance showing permanent water August 2013.

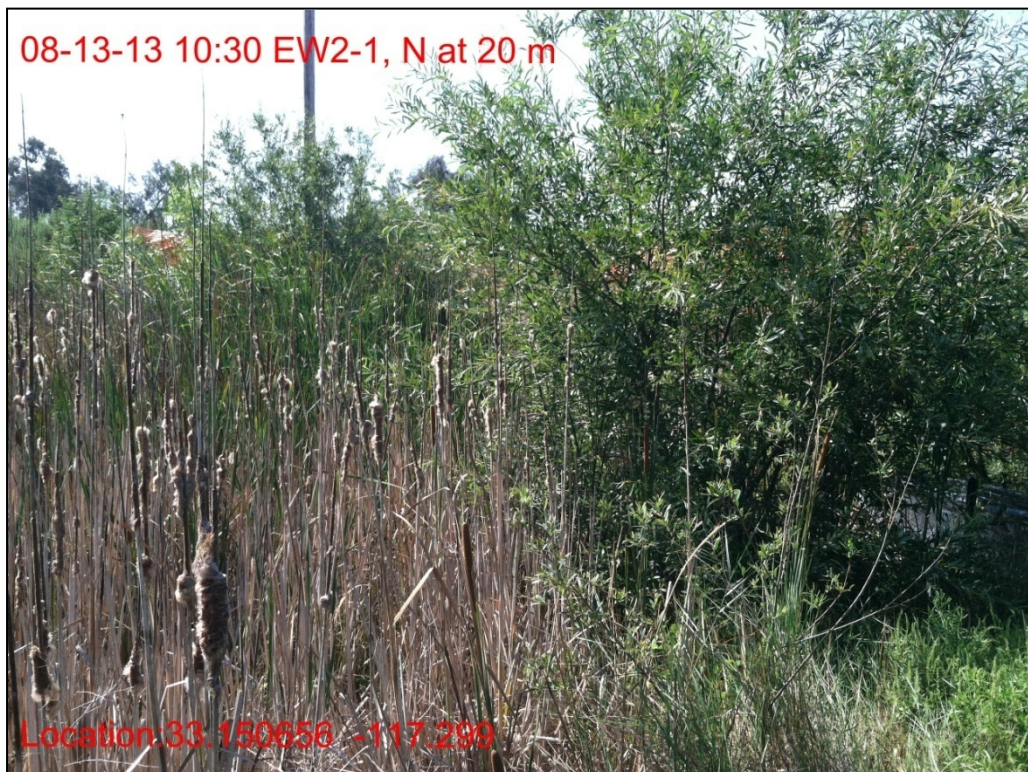
EW2-1, N end at 20 meters showing thick vegetation, August 2013.

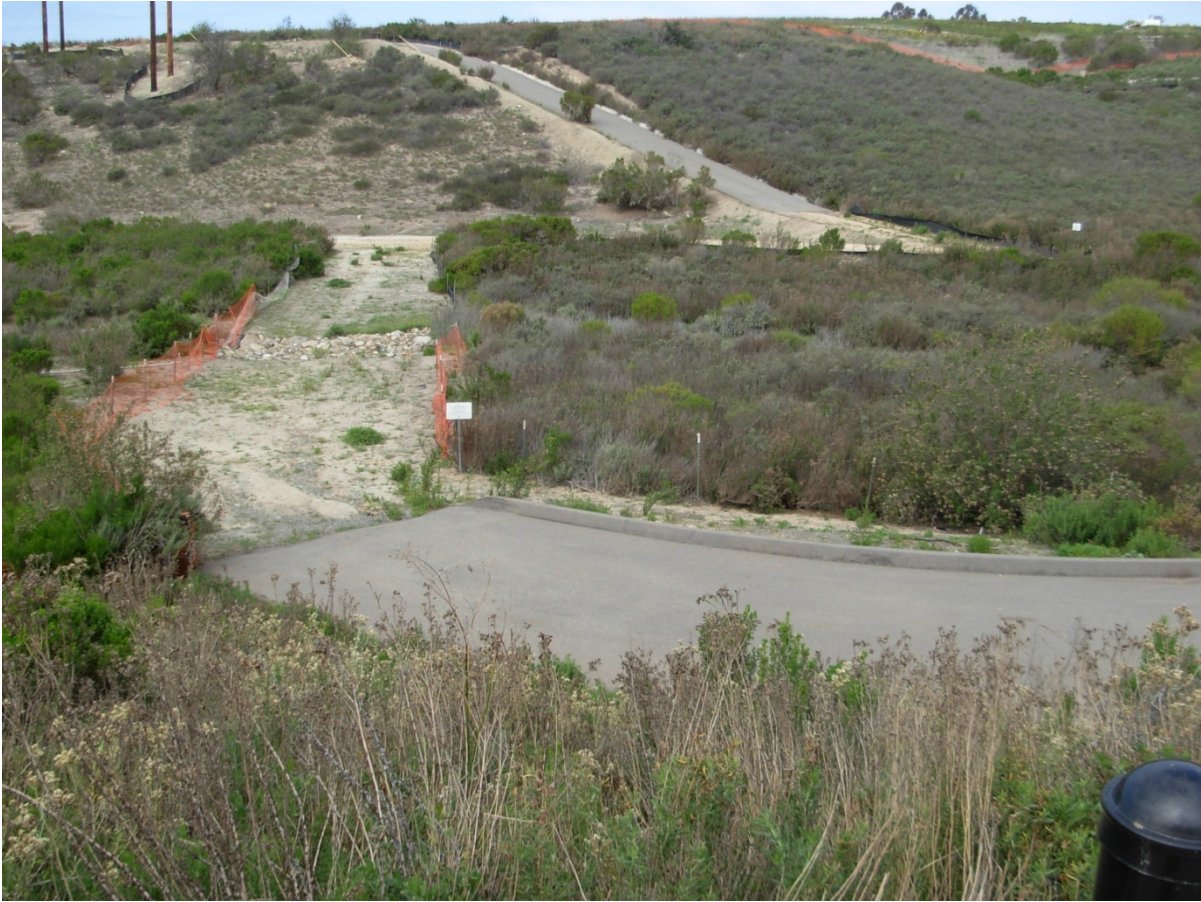
EW2-2, looking west from adjacent developed residential property.

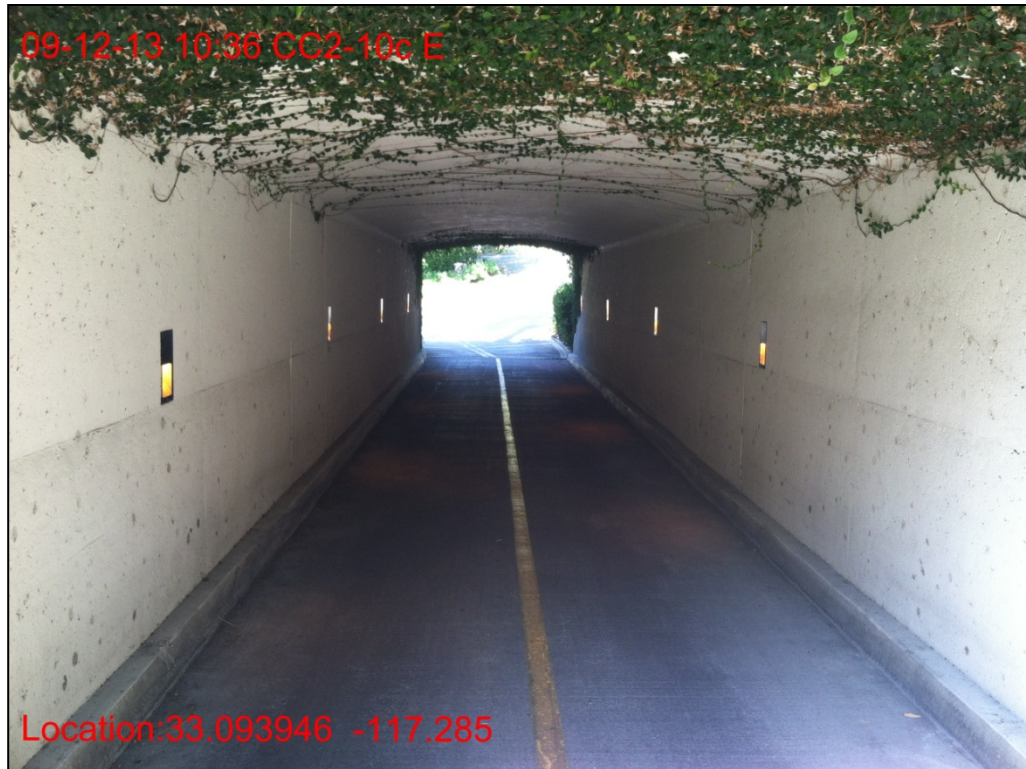
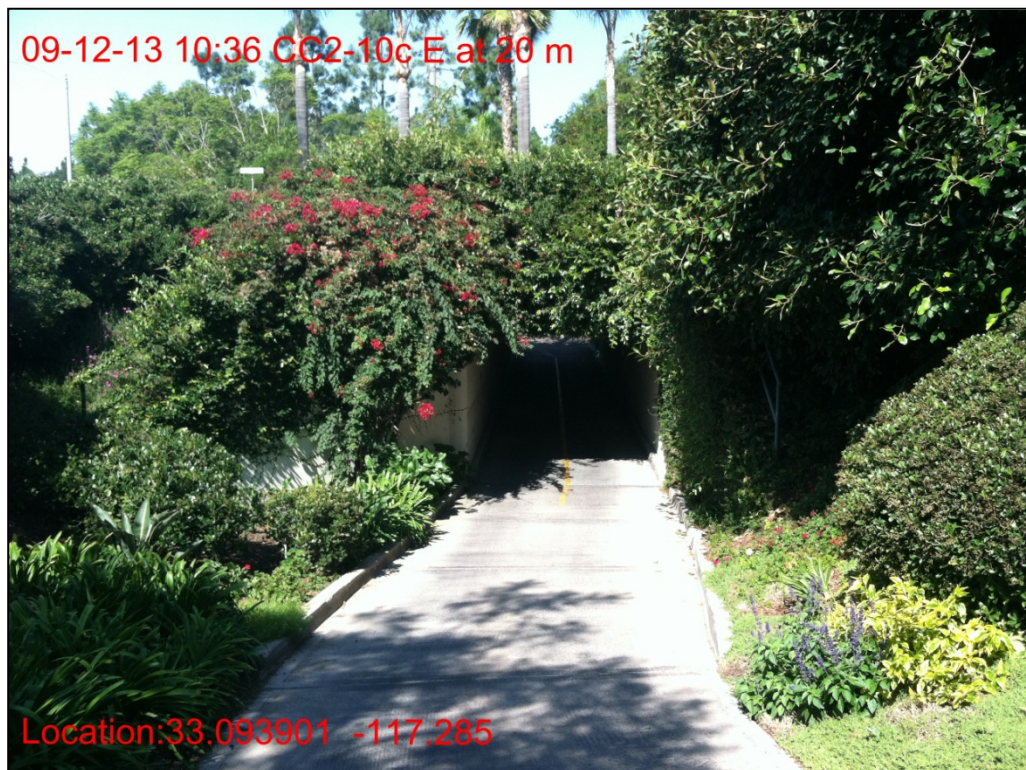
CC2-10c, east side facing undercrossing, September 2013.

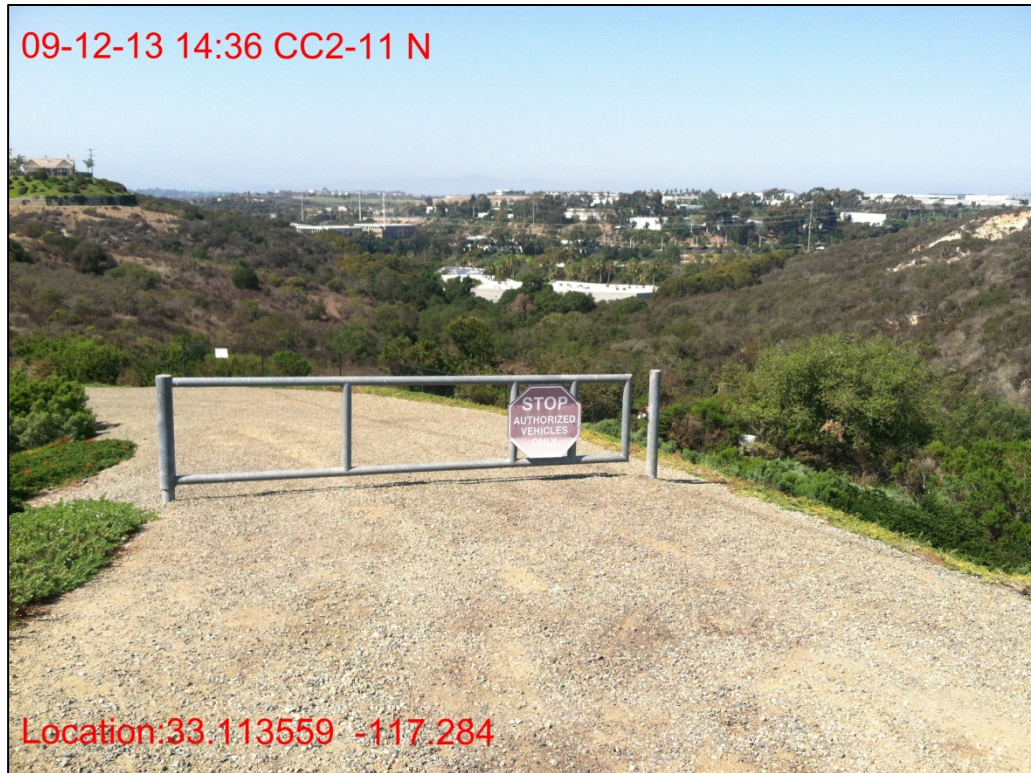
CC2-11, looking north from north side, September 2013.

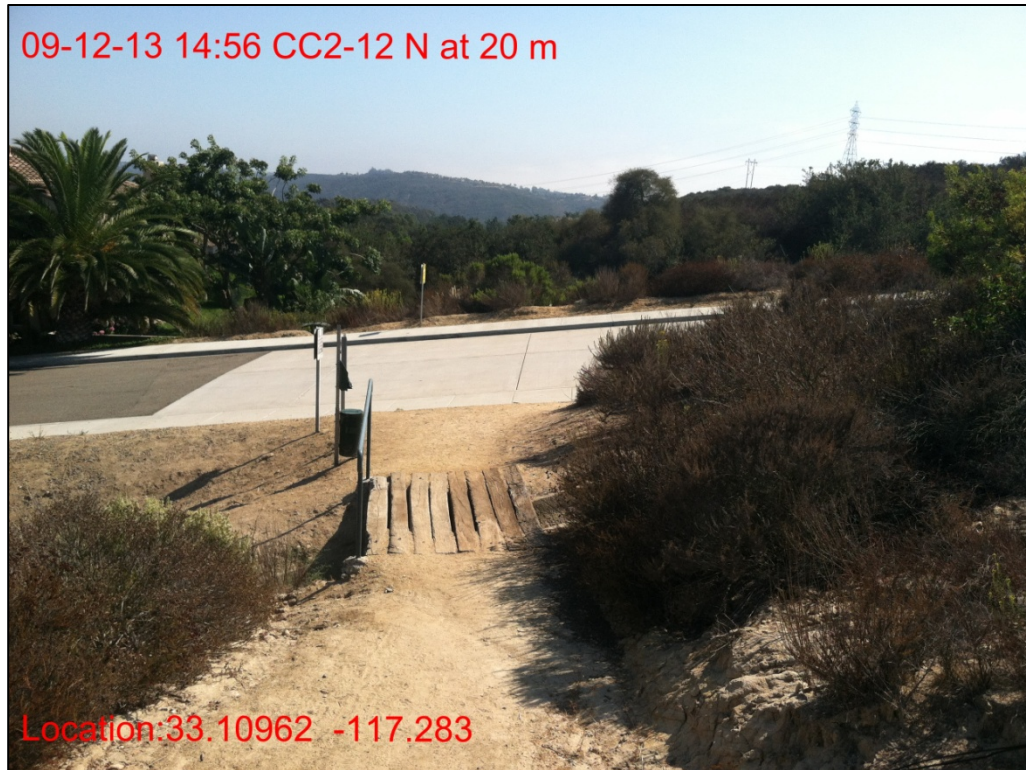
CC2-12, north side, at-grade crossing at 20 m out, September 2013.

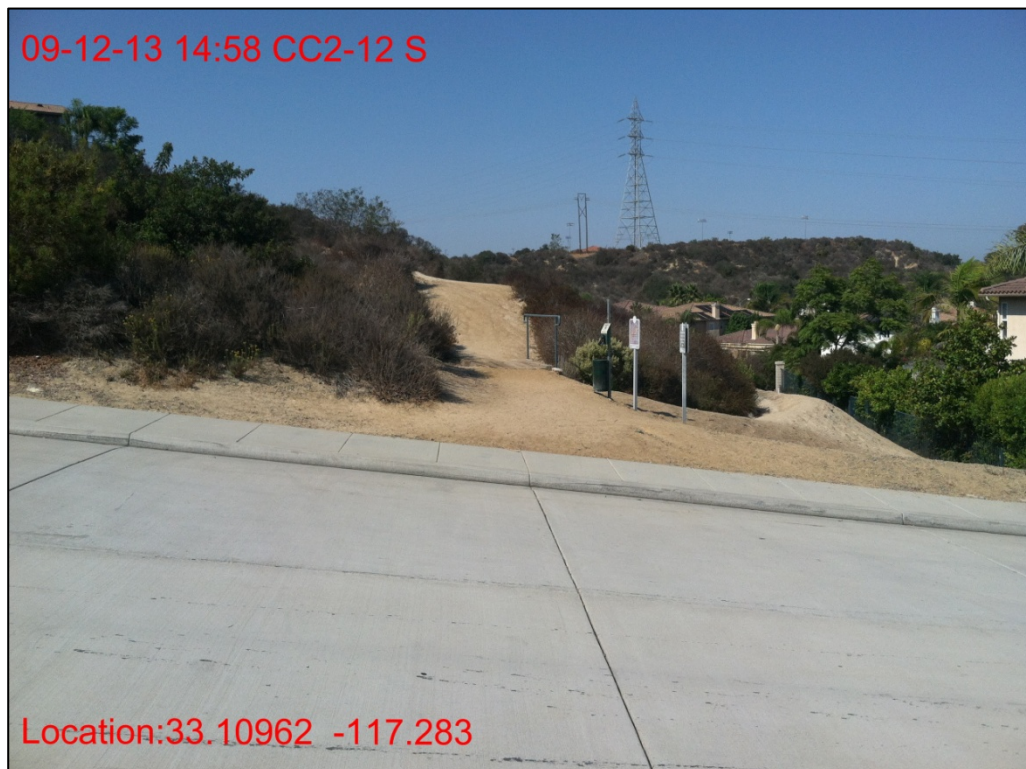
CC2-12, south side, September 2013.

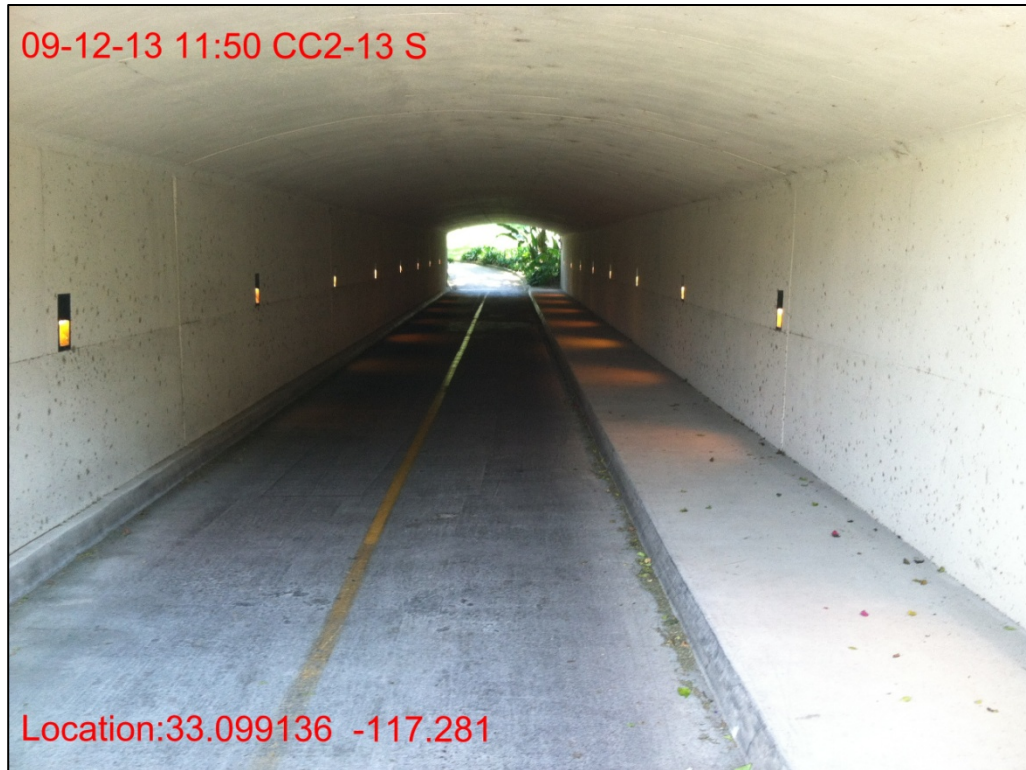
CC2-13, south side facing into undercrossing, September 2013.

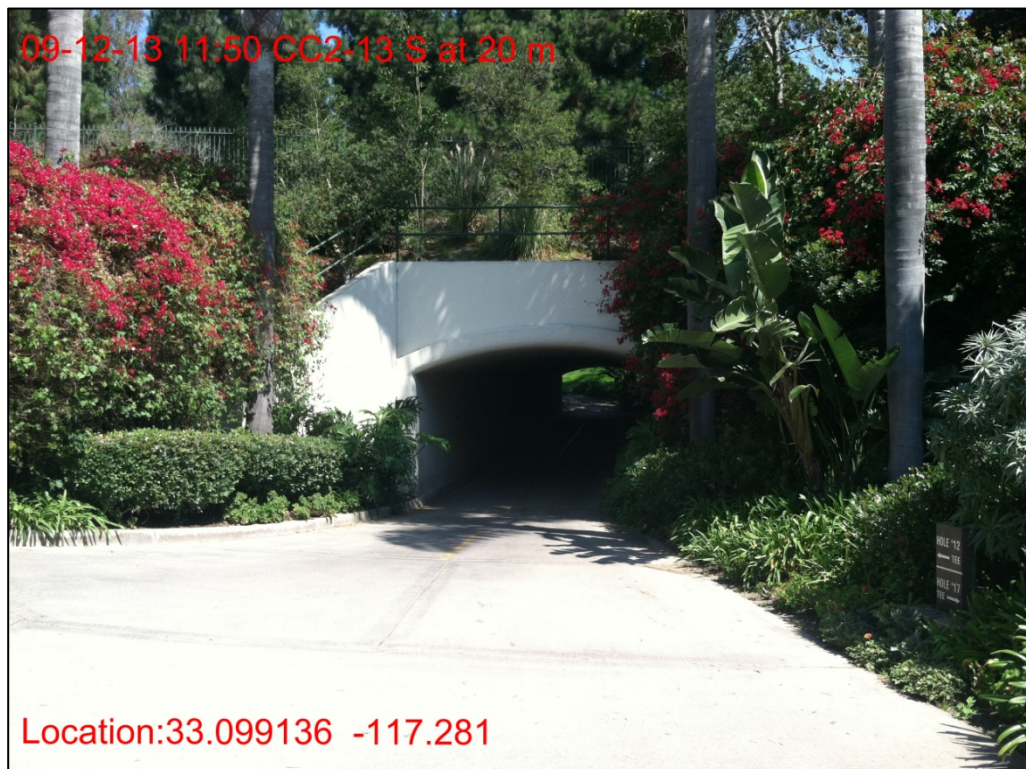
CC2-13, south side at 20 m out, September 2013.

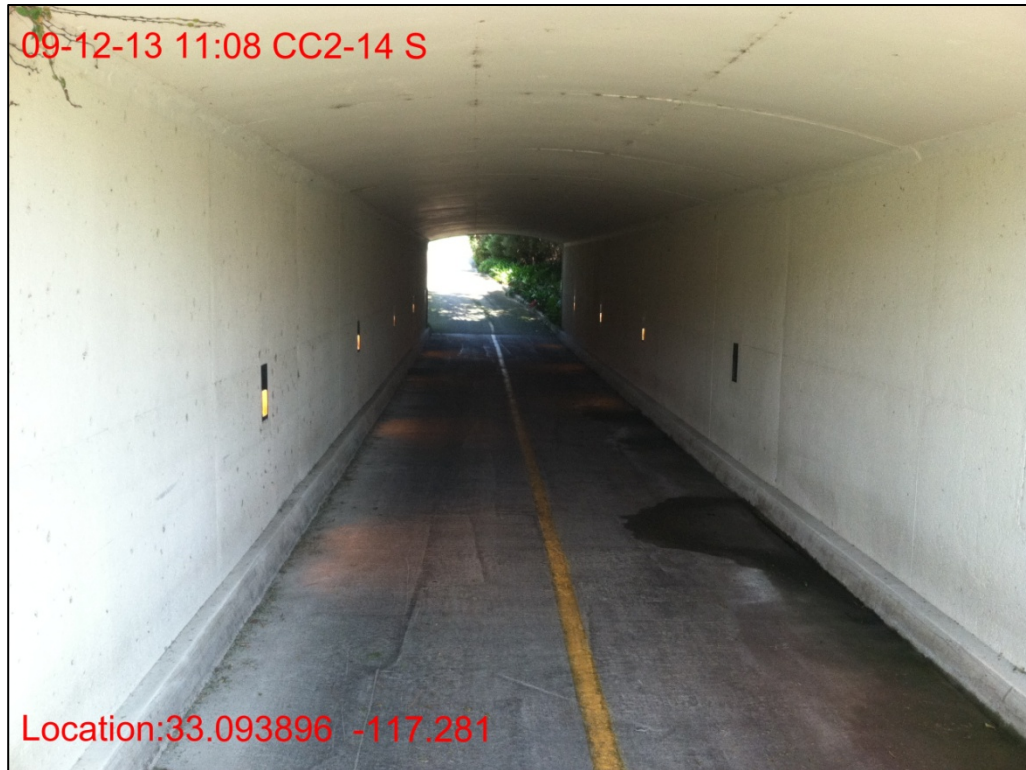
CC2-14, south side facing into undercrossing, September 2013.

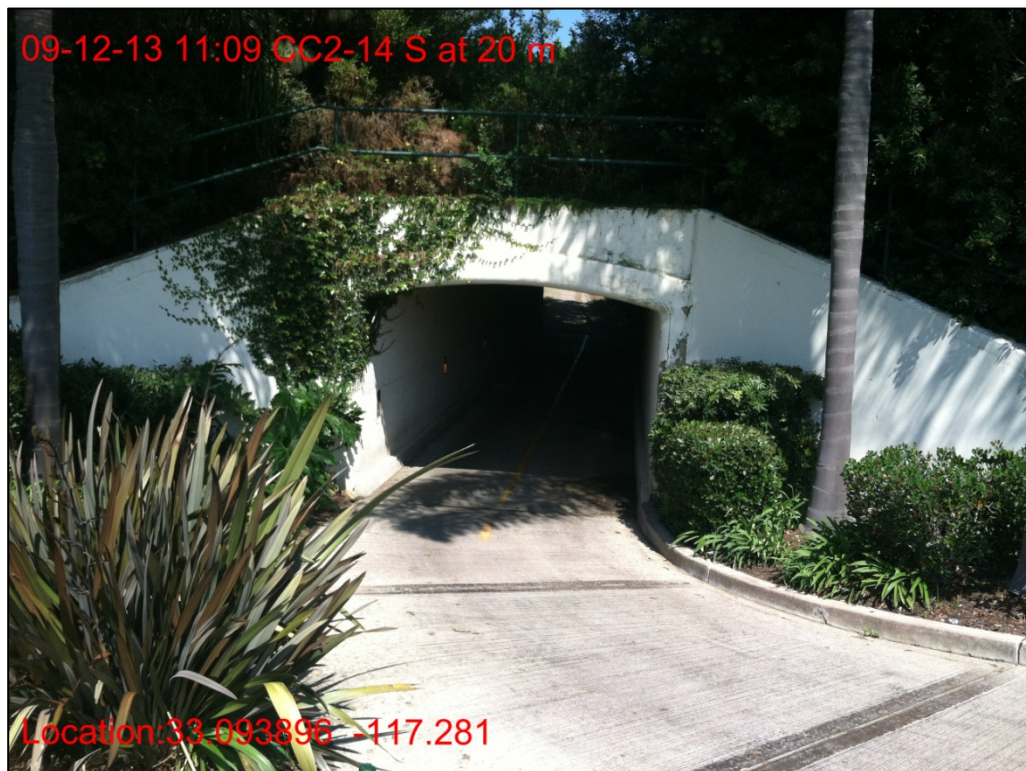
CC2-14, south side at 20 m out, September 2013.

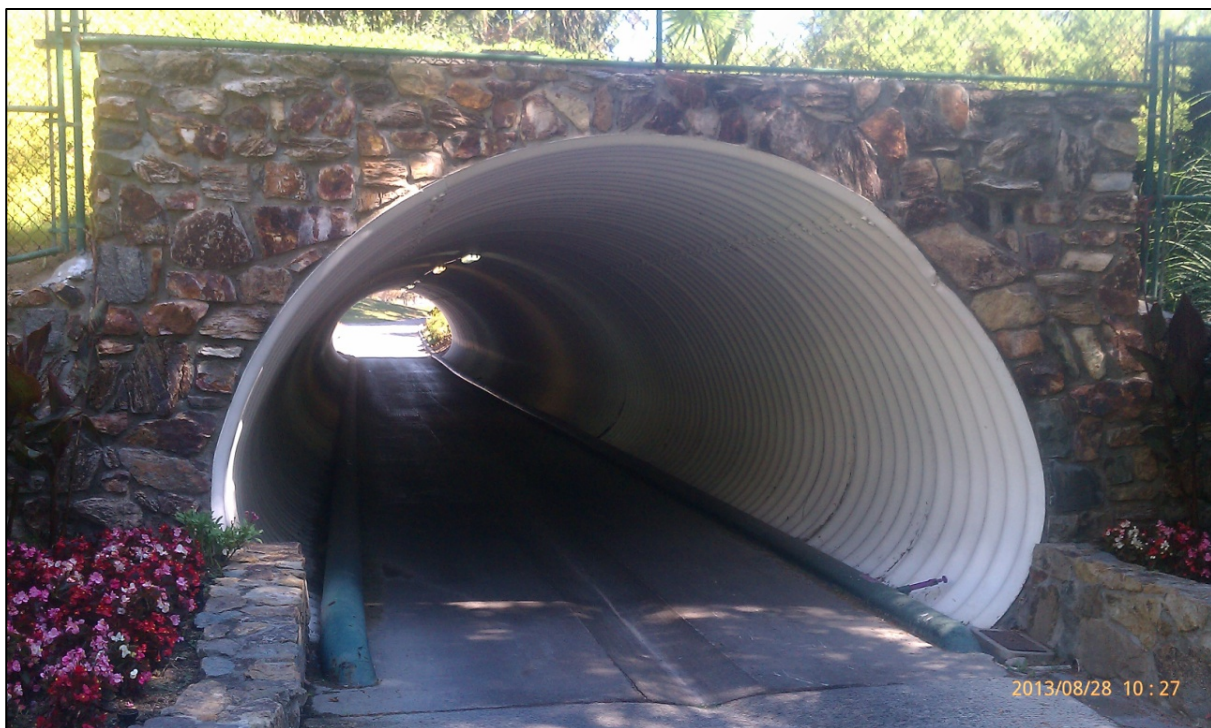
CC3-1 south side facing north, golf cart path entrance, October 2013.

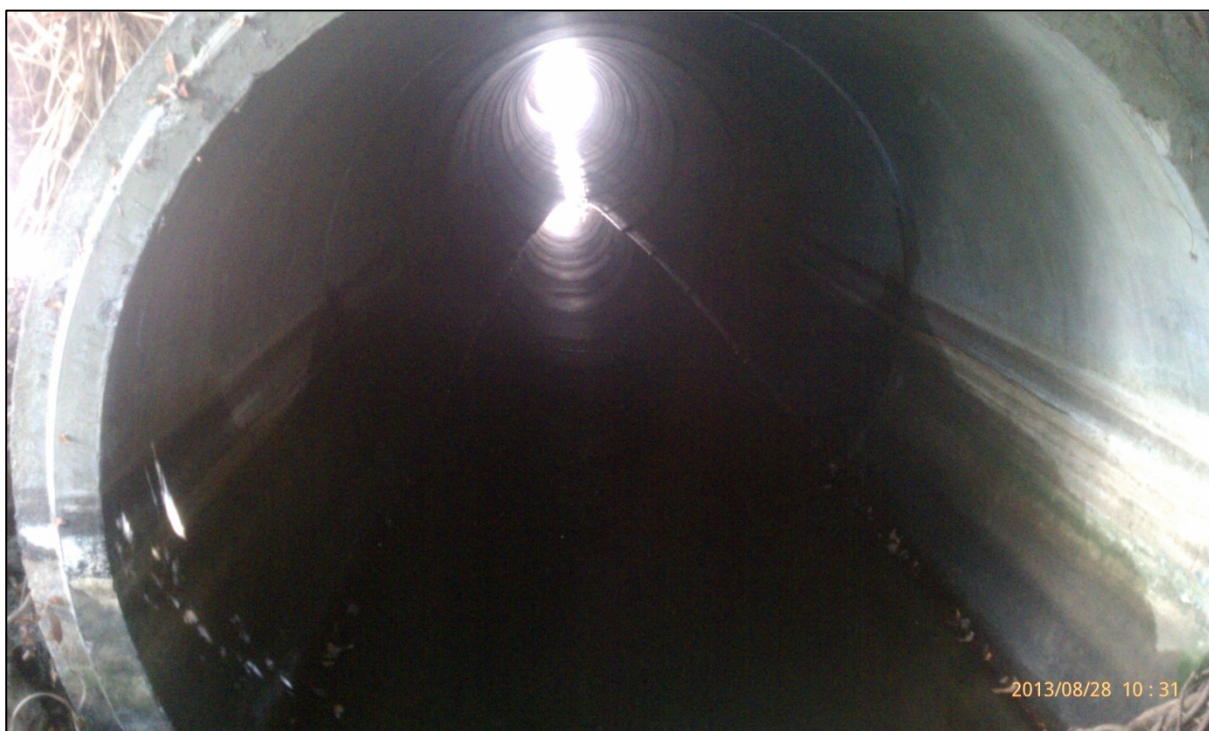
CC3-1 south entrance looking north, alternate route through pipe, October 2013.

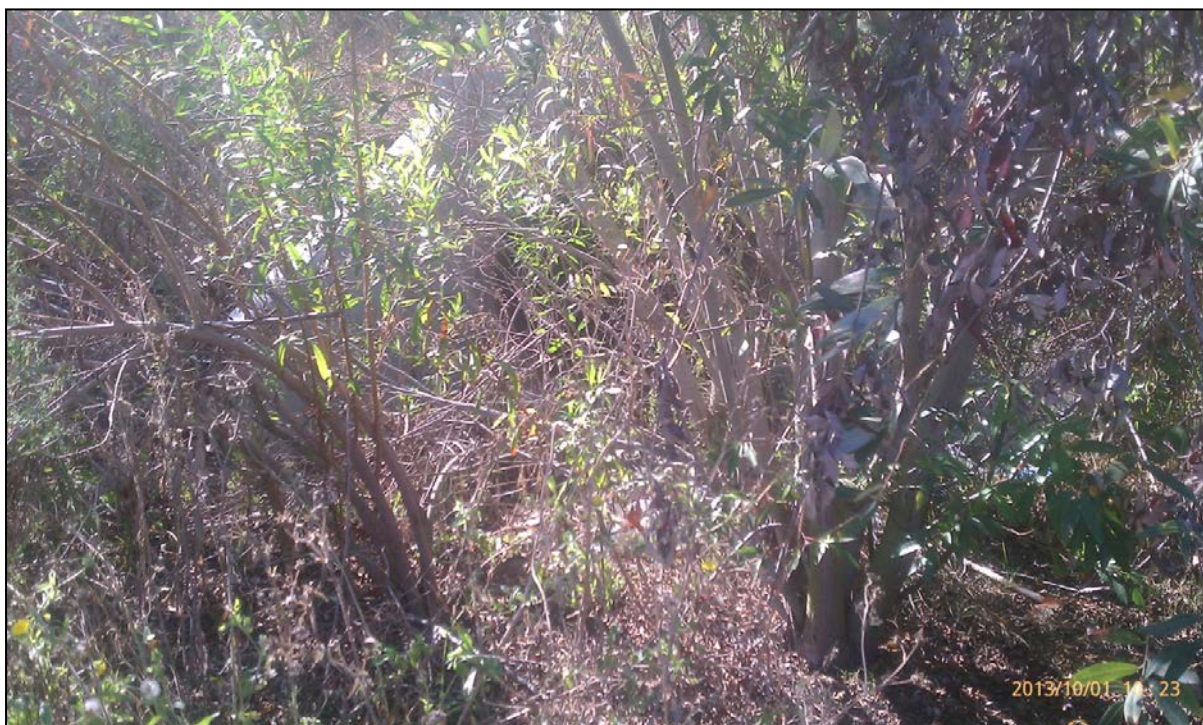
CC3-3b, north side looking south, showing that entrance is blocked by vegetation, October 2013.

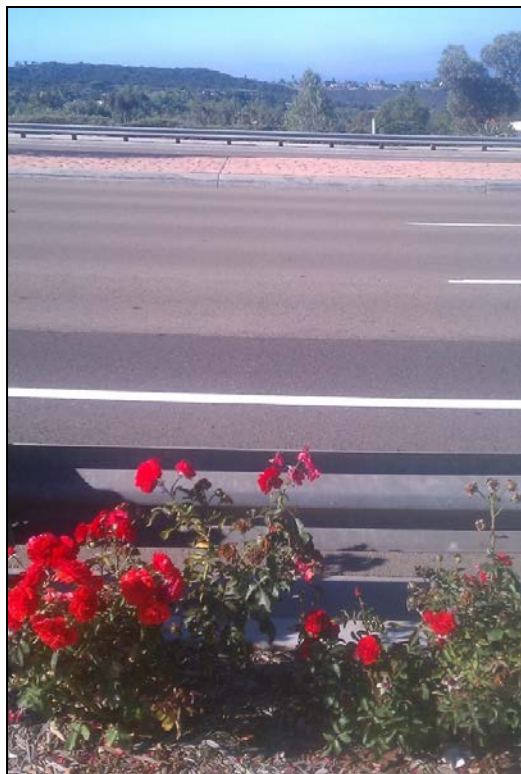
CC3-4, east side looking west, October 2013.

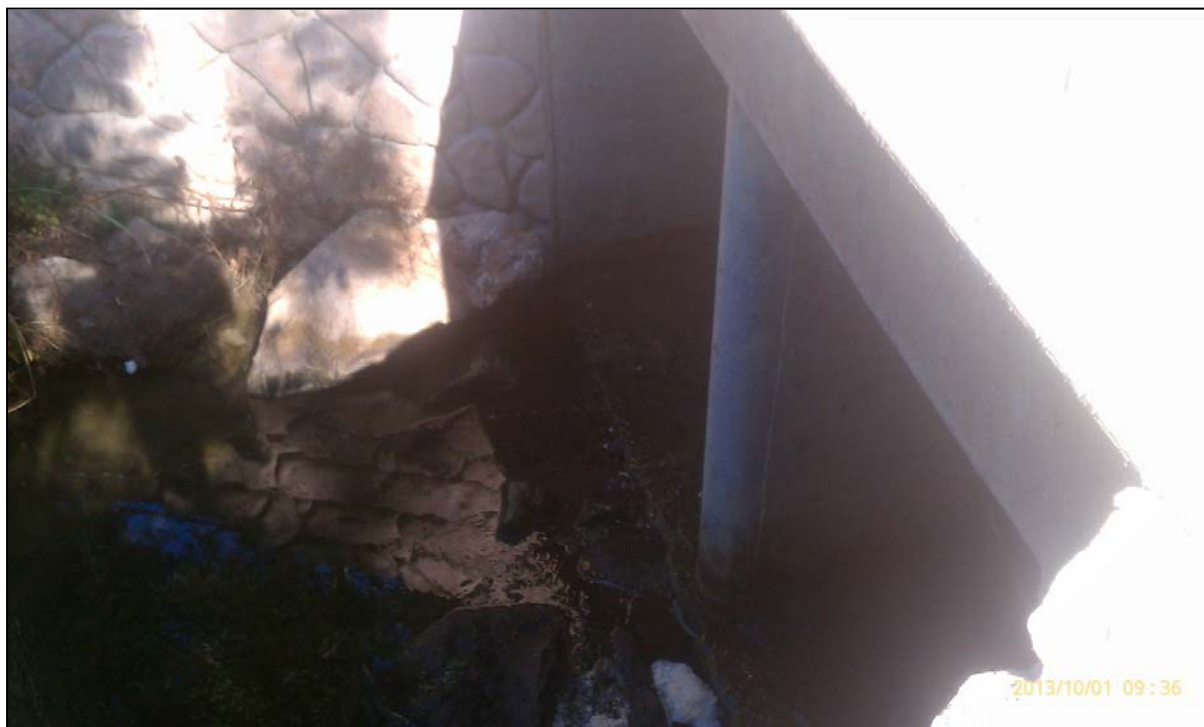
CC3-4, west side outlet from spillway, October 2013.

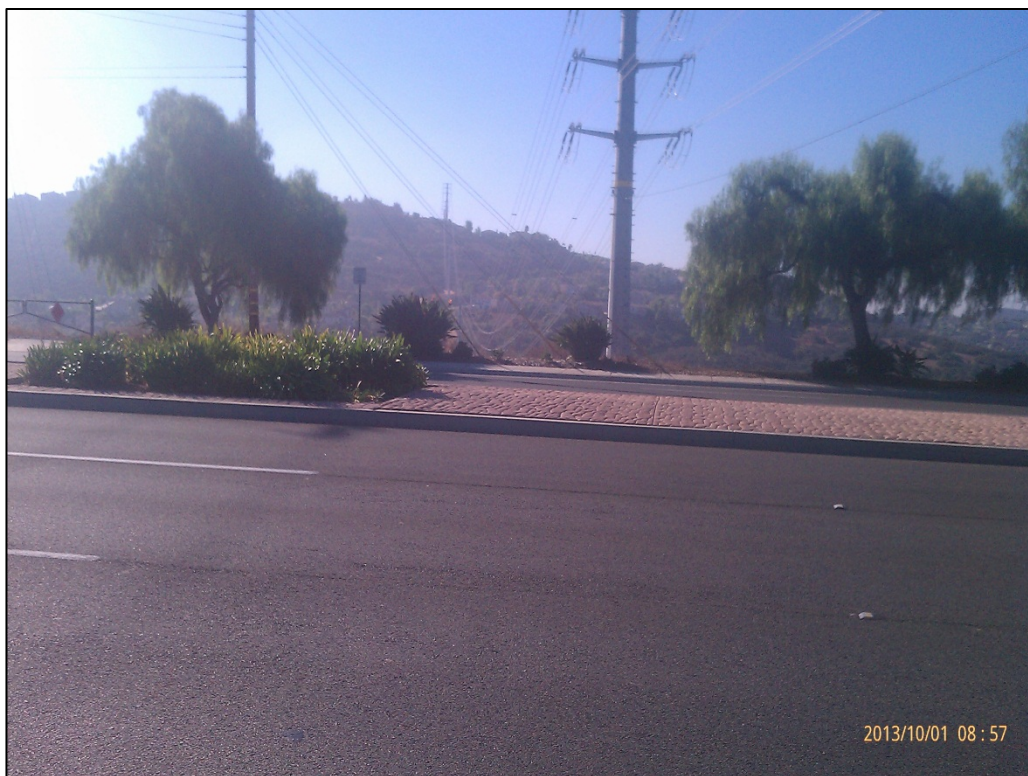
CC3-5, looking south from north side, October 2013.

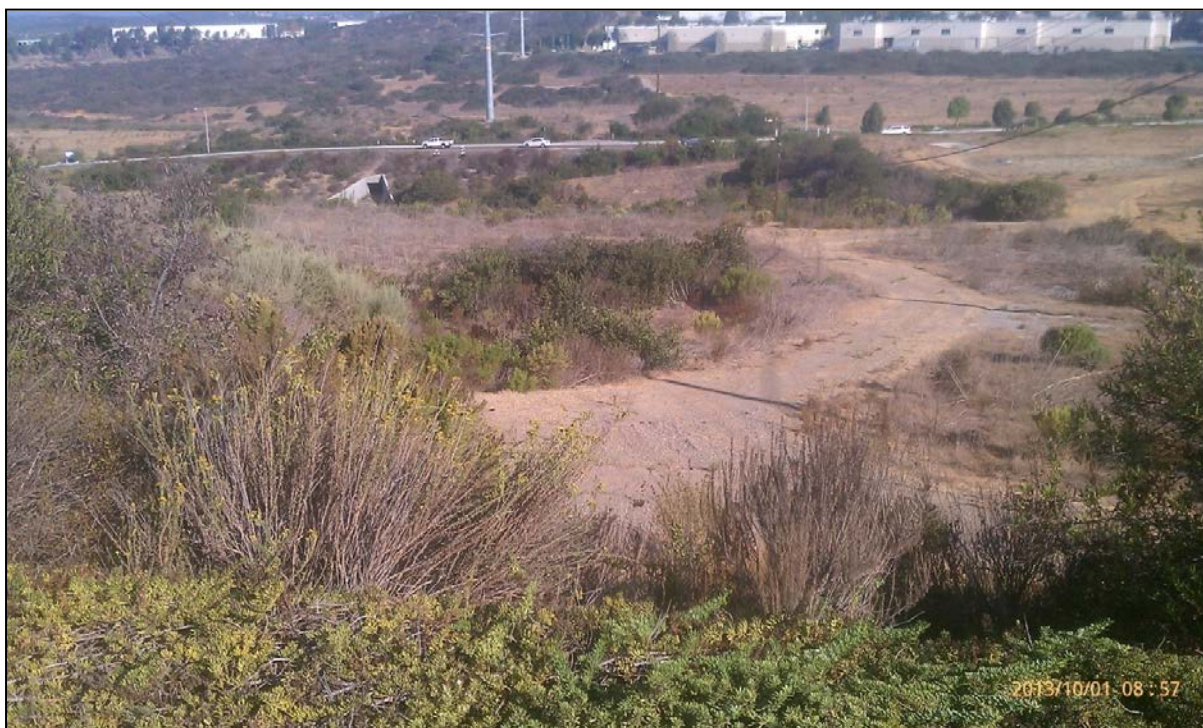
CC3-5, north side looking north (line of sight to M7-5), October 2013

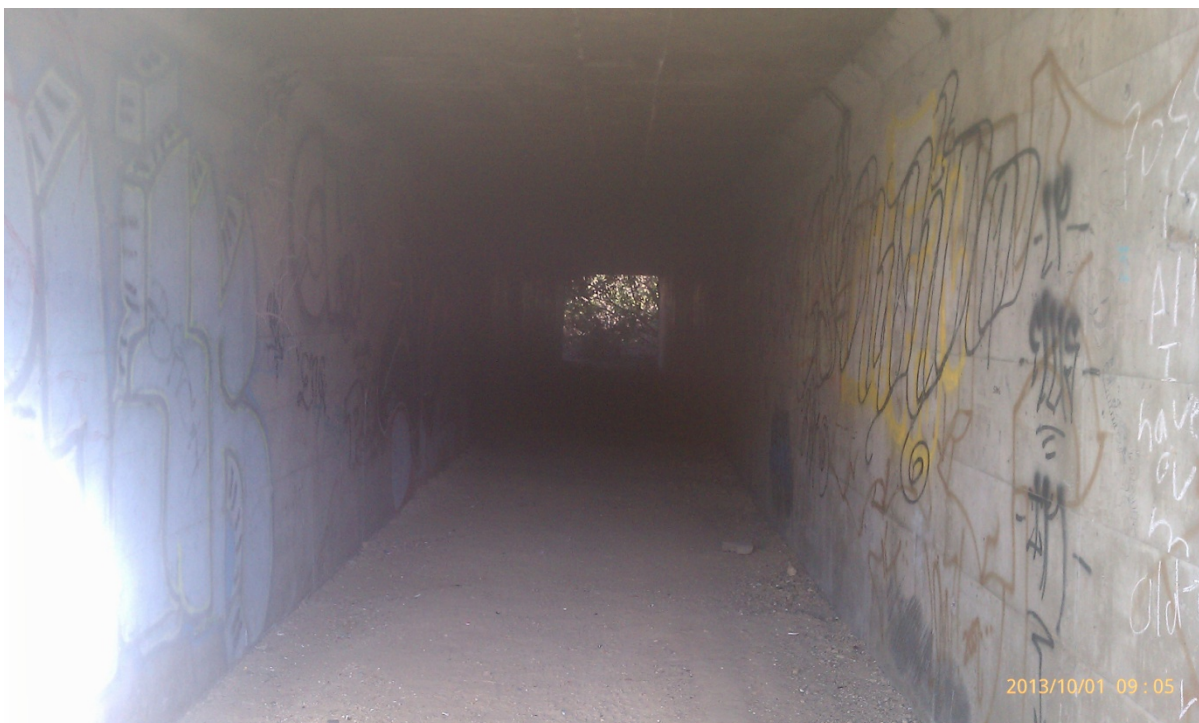
CC3-6. South side looking north from entrance, October 2013

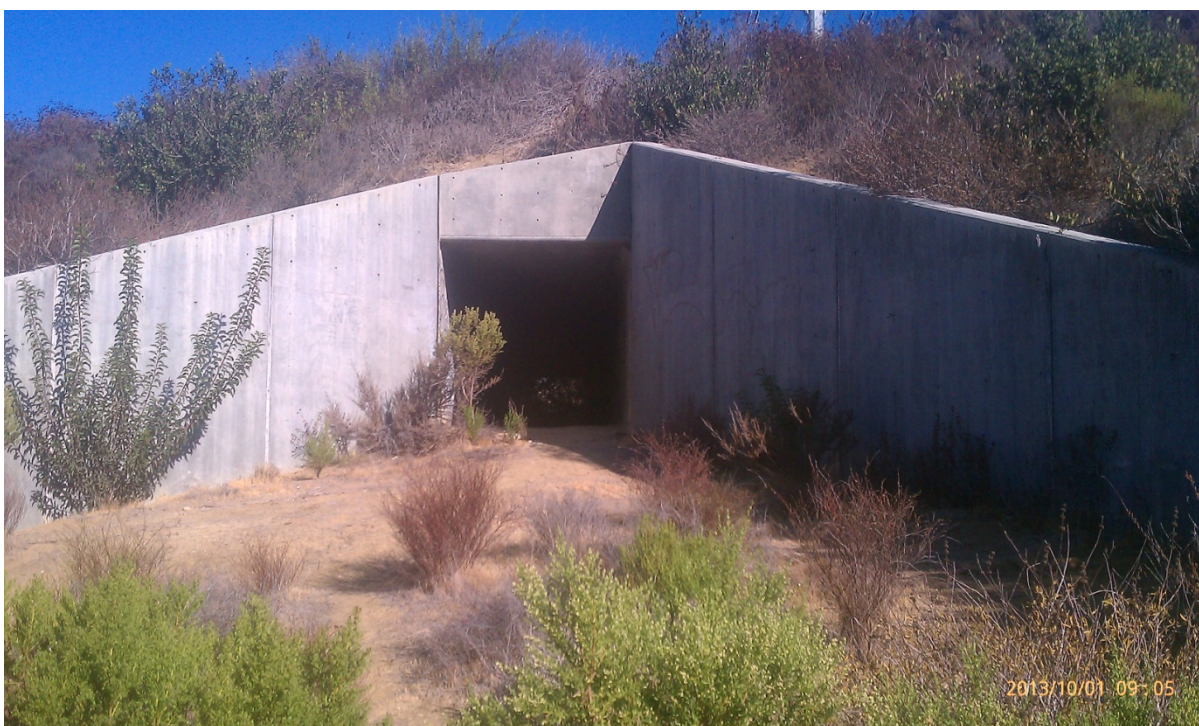
CC3-6. South side looking north from 30 feet out, October, 2013.

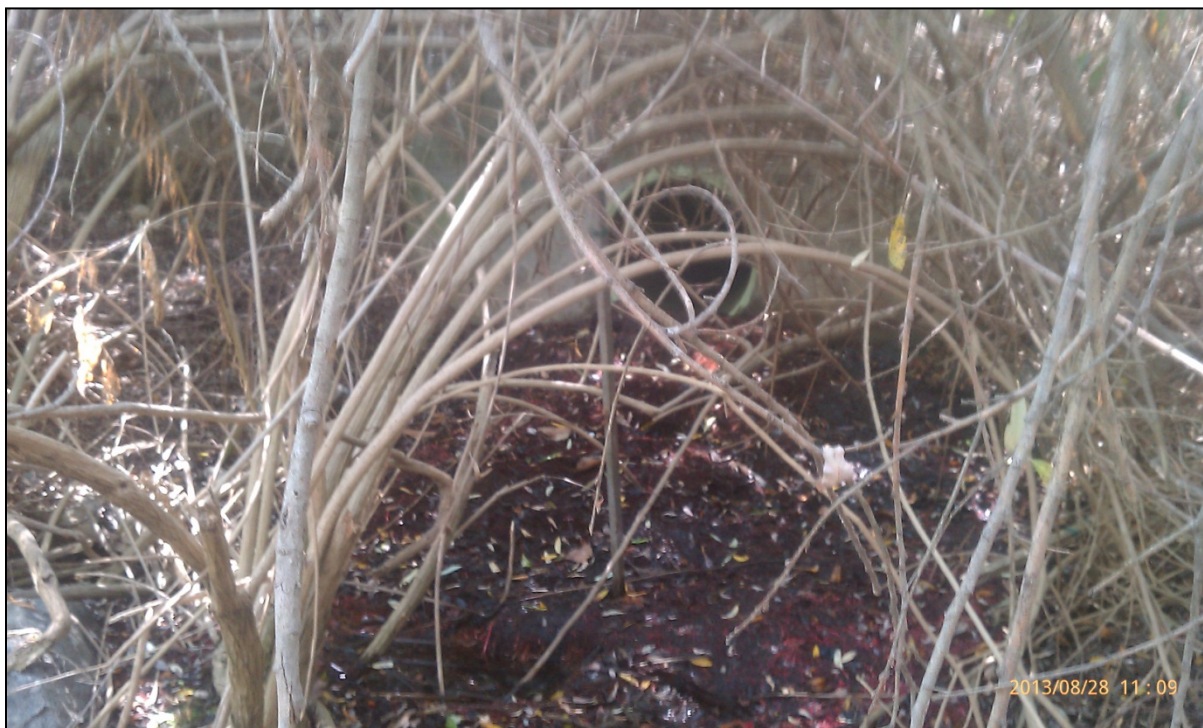
M1-1, north side showing small pipe outlet, August 2013.
