# City of Carlsbad Wildlife Movement Analysis Final Report

Local Assistance Grant Agreement No.  
P1282107

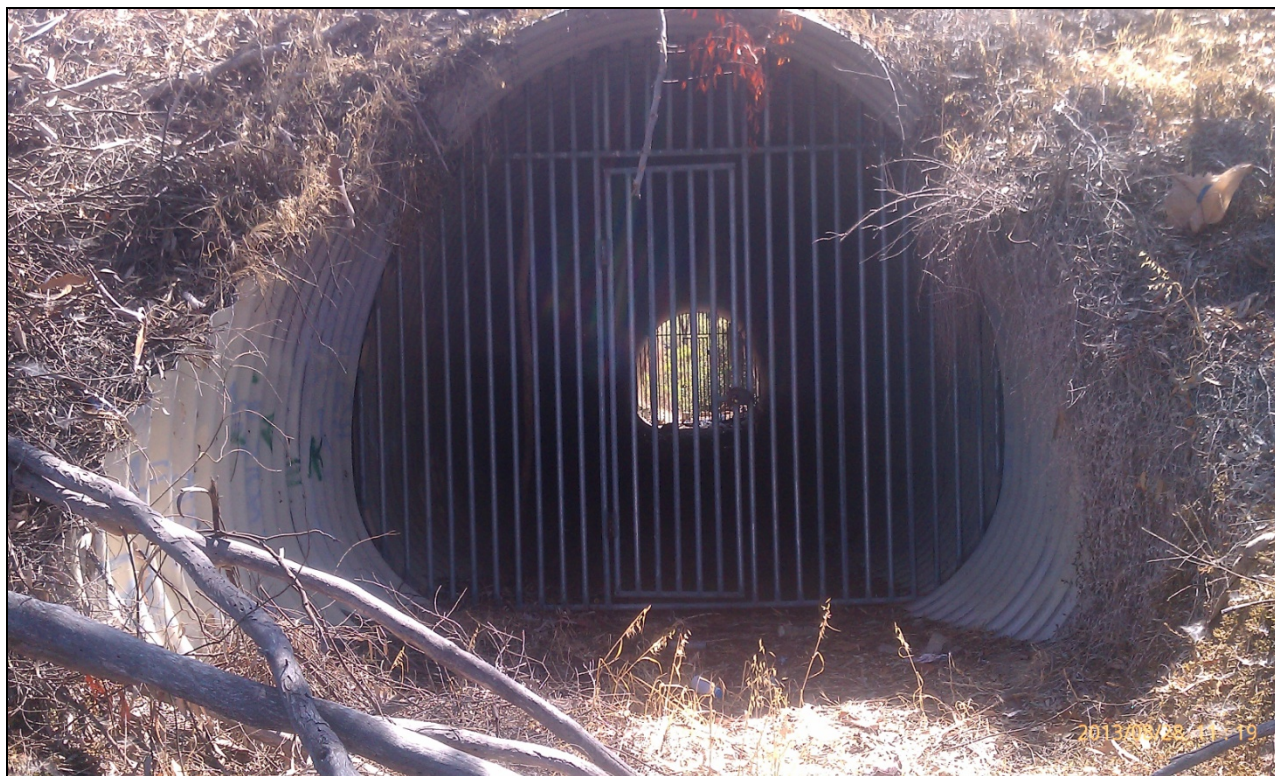
M1-2 – west side facing east, showing locked gate at both ends, August 2013.

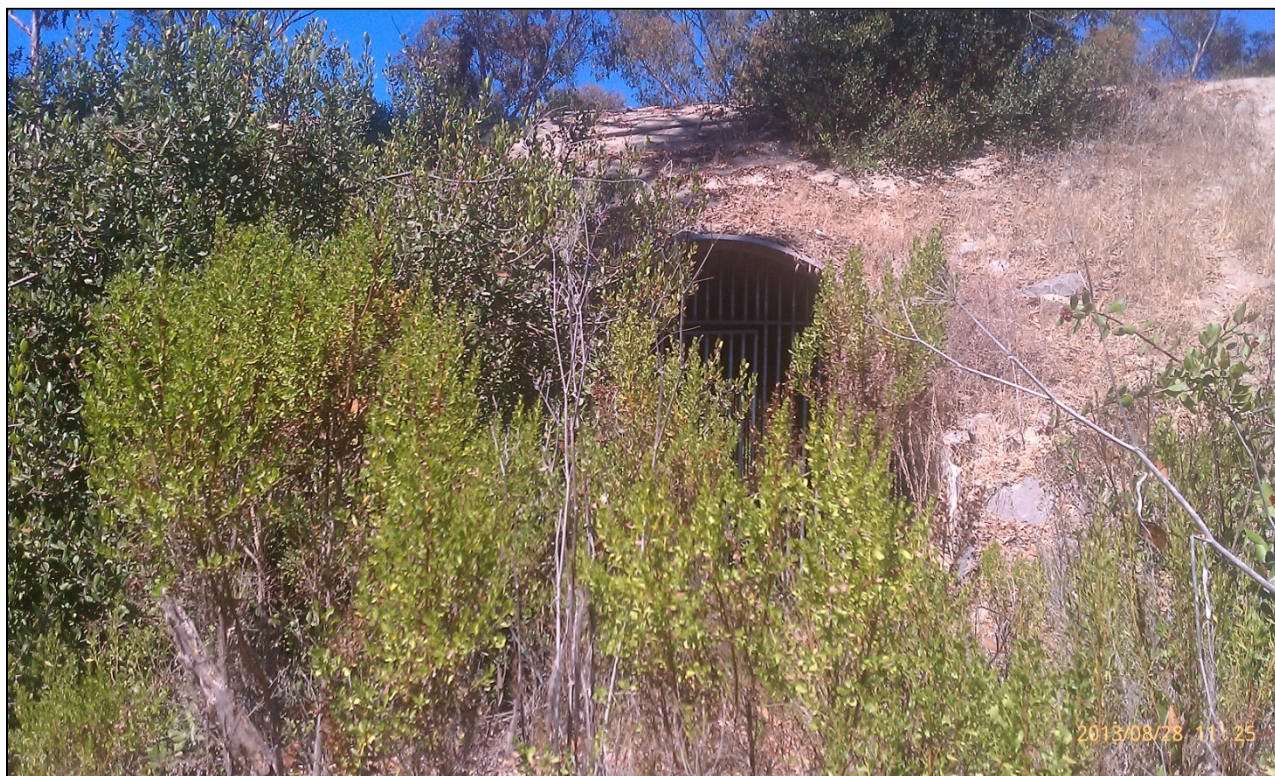
M1-2 east side facing west, August 2013.

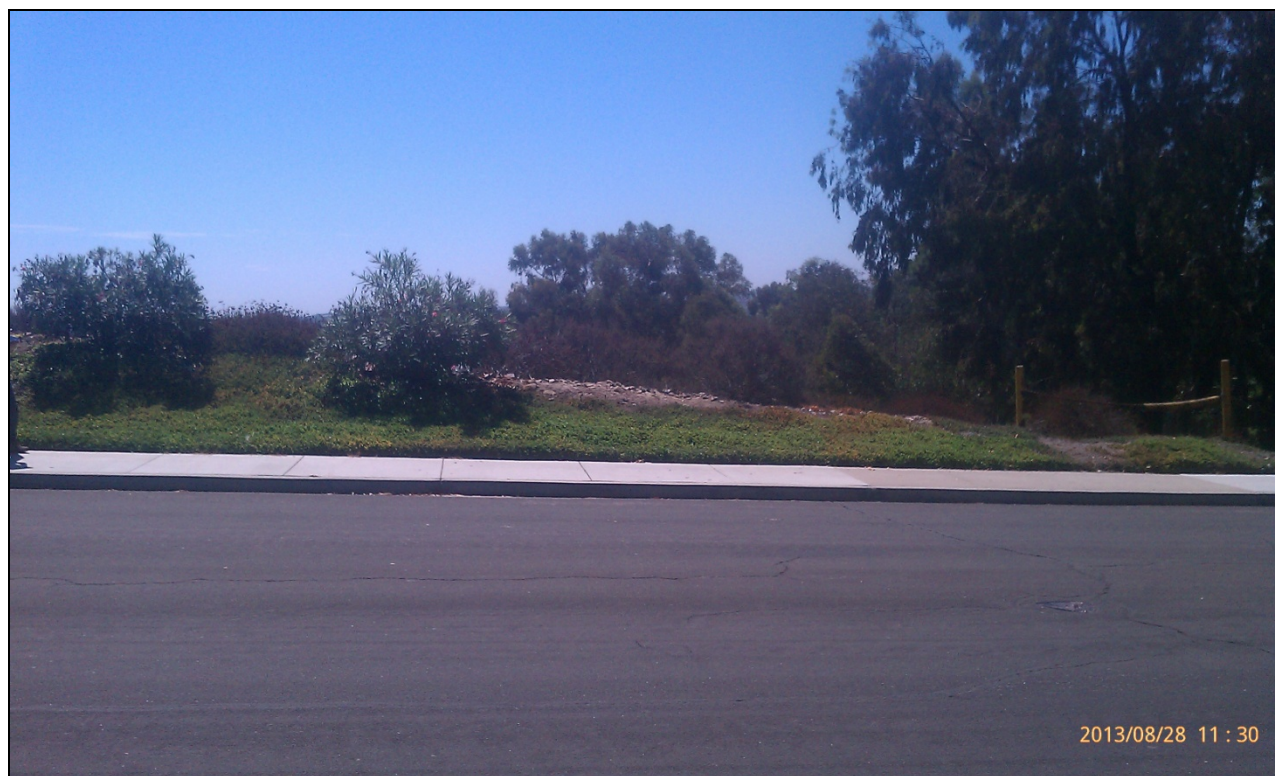
M1-3, at-grade crossing, north side facing south, August 2013.

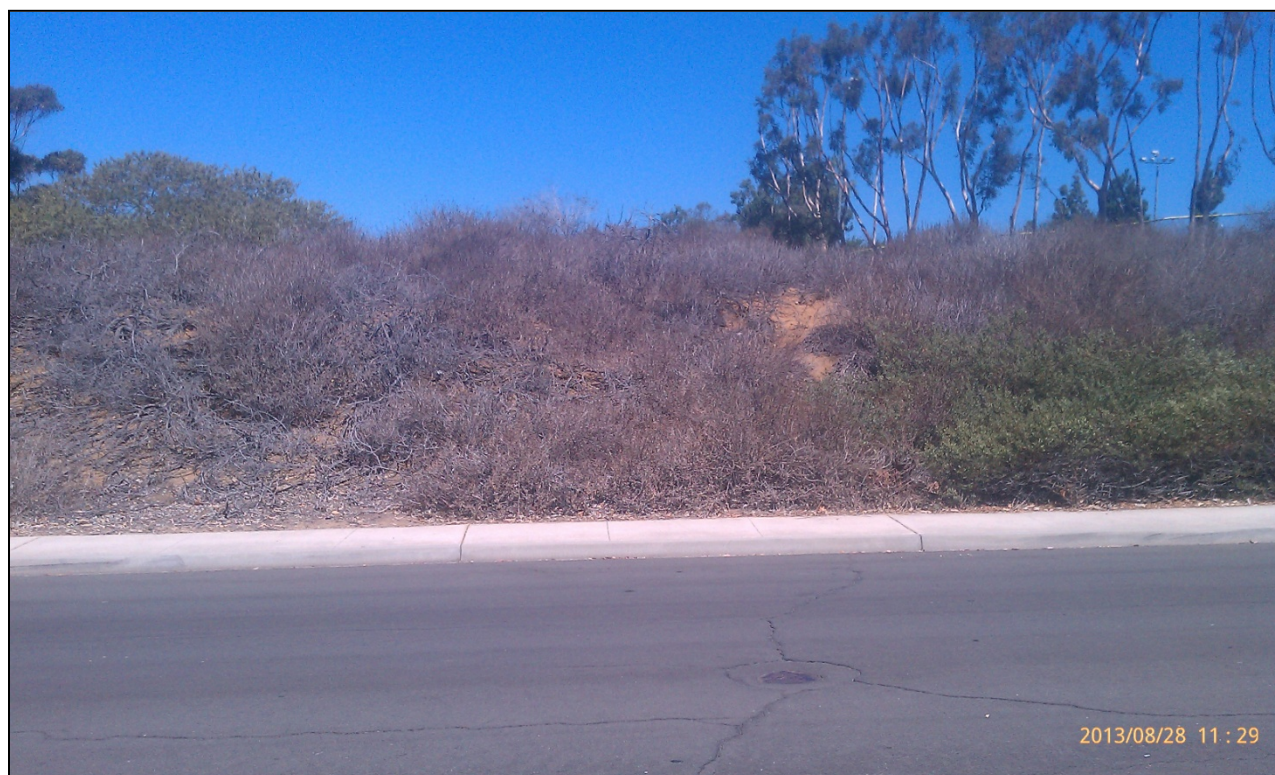
M1-3, south side facing north, August 2013.

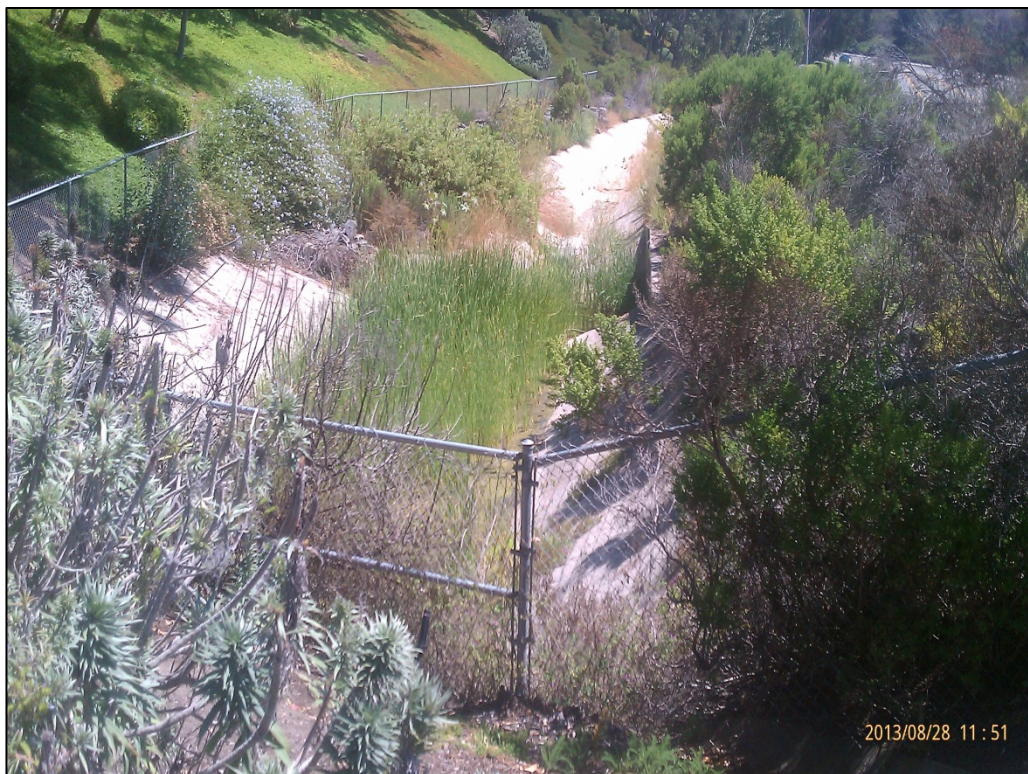
M1-4, looking north from west end, August 2013.

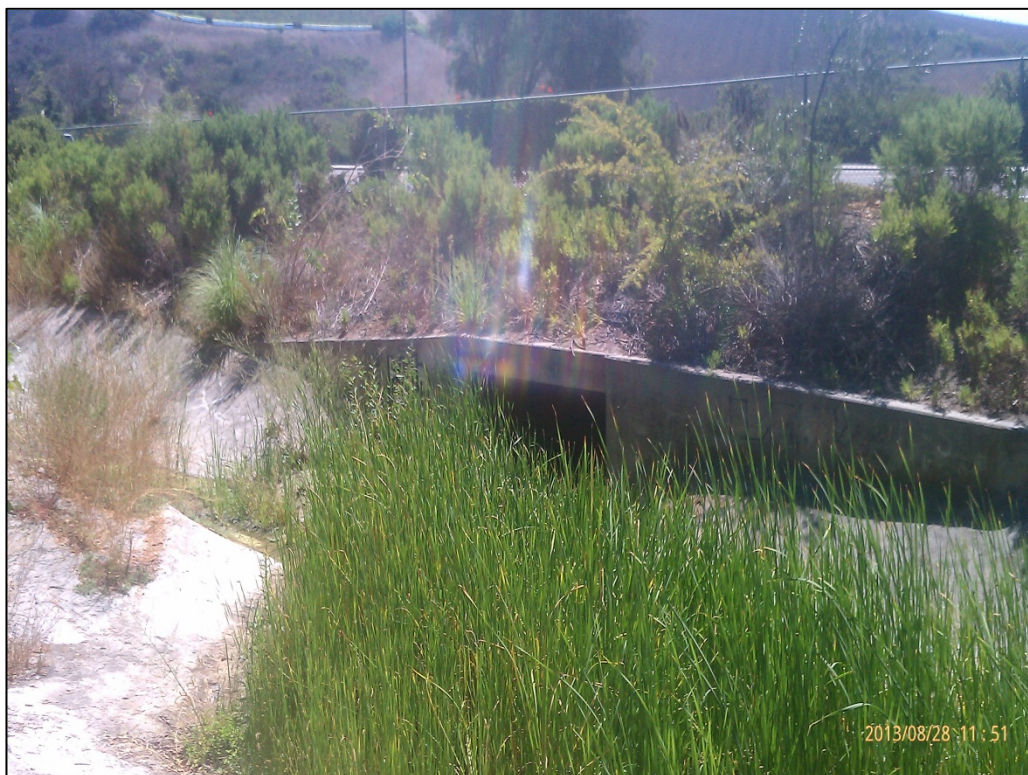
M1-4, looking east from west end, August 2013.

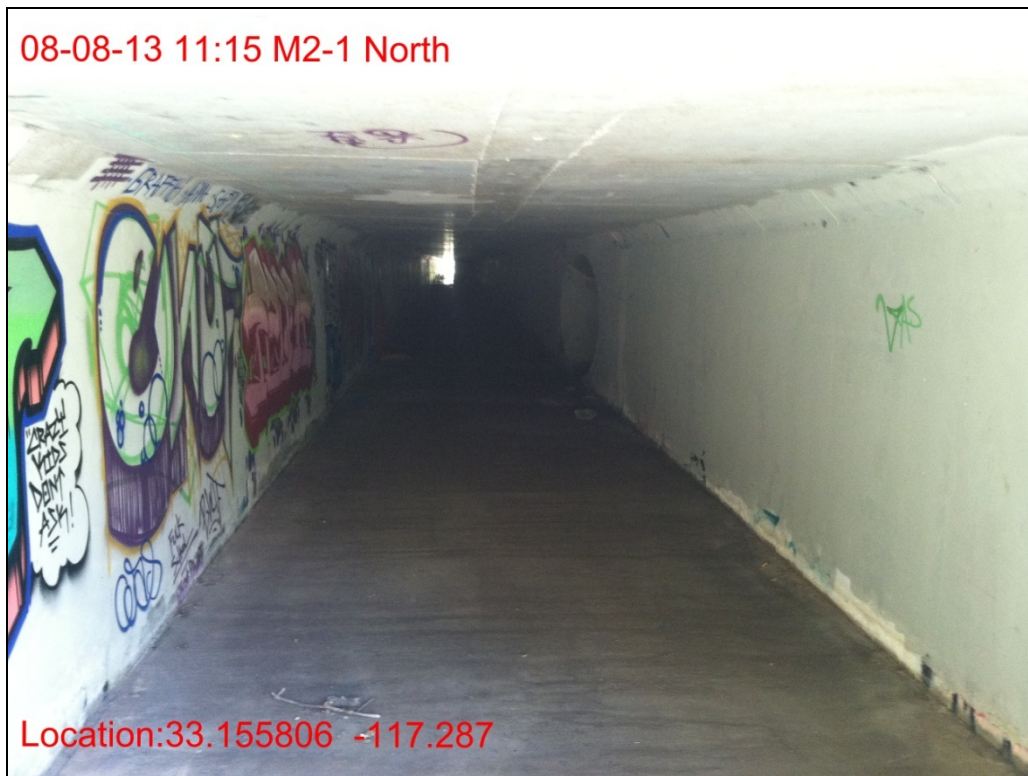
M2-1, north end facing south into undercrossing, August 2013.

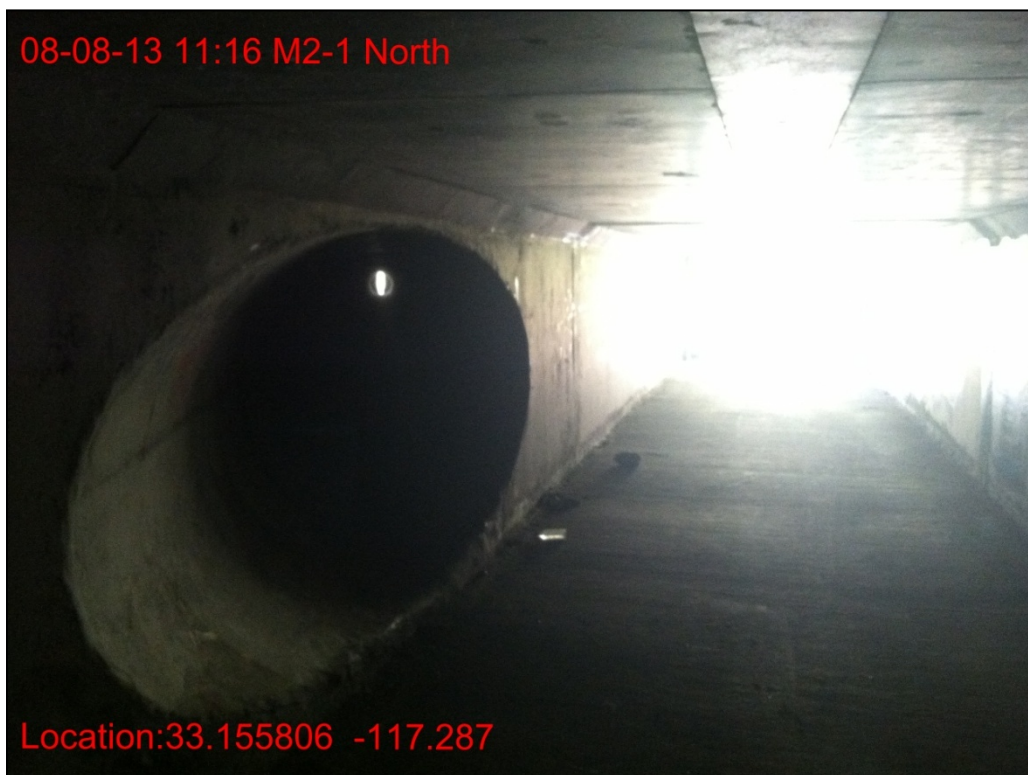
M2-1, north side facing north, showing offshoot pipe, August 2013.

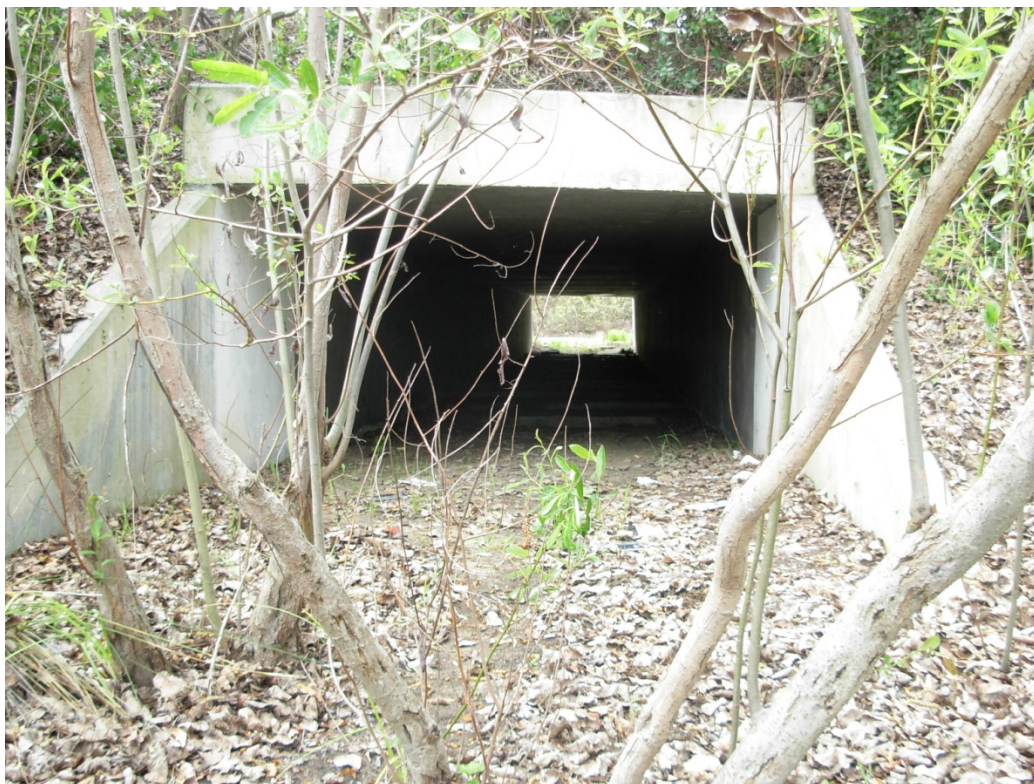
M5-1, looking south from north entrance.

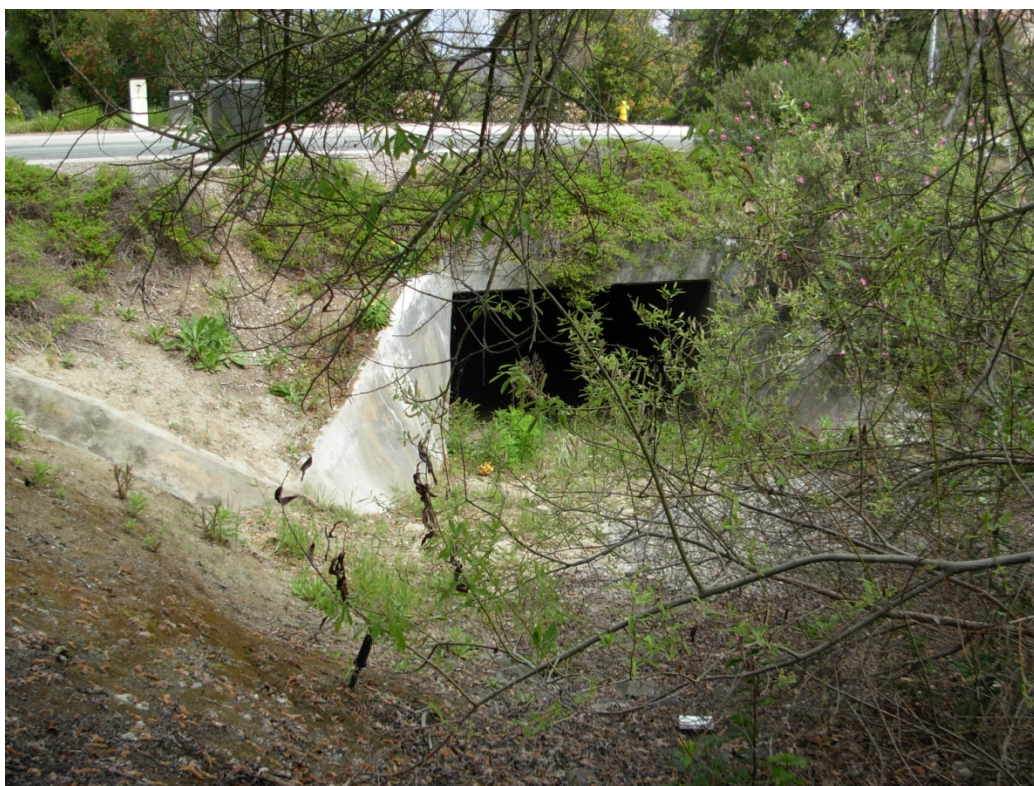
M5-1, looking north at 20 meters from south entrance.

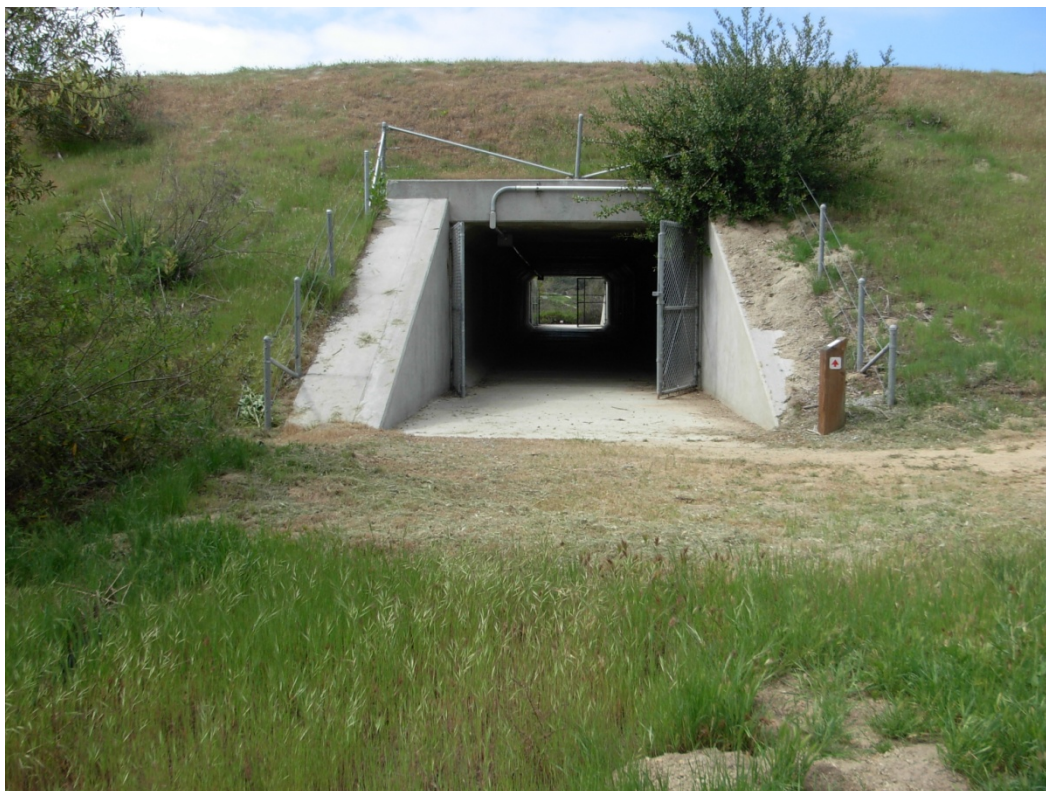
M5-2a, looking south towards north entrance.

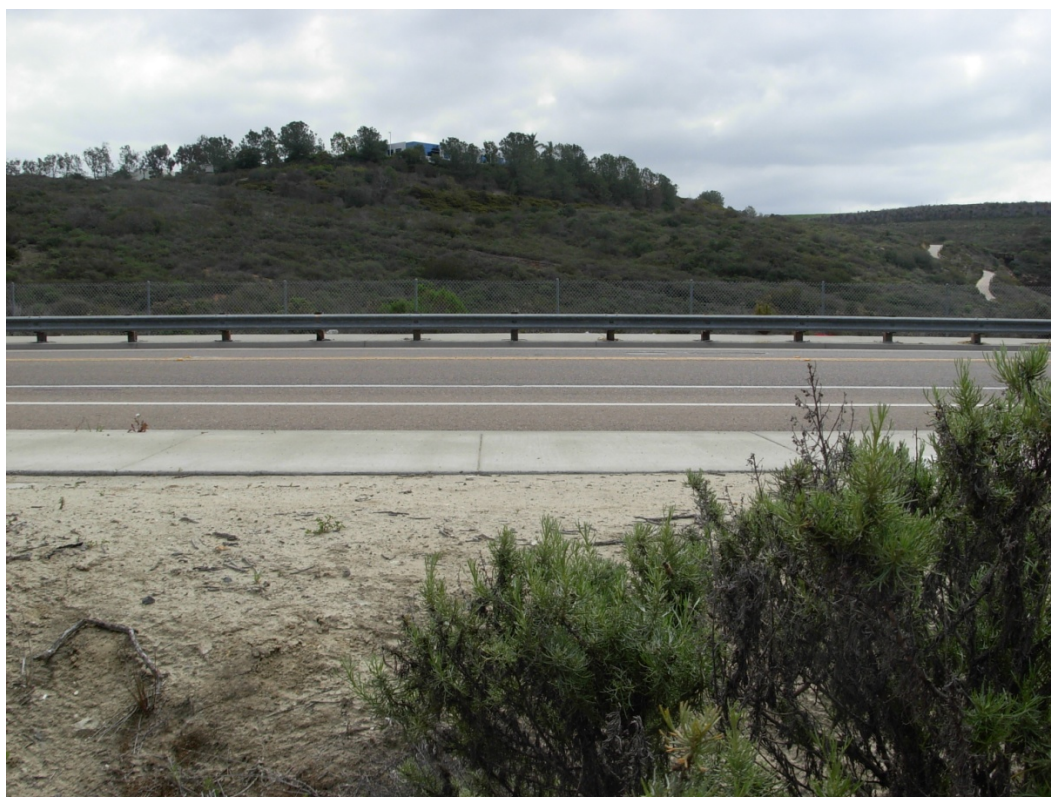
M5-2b, north side looking south.

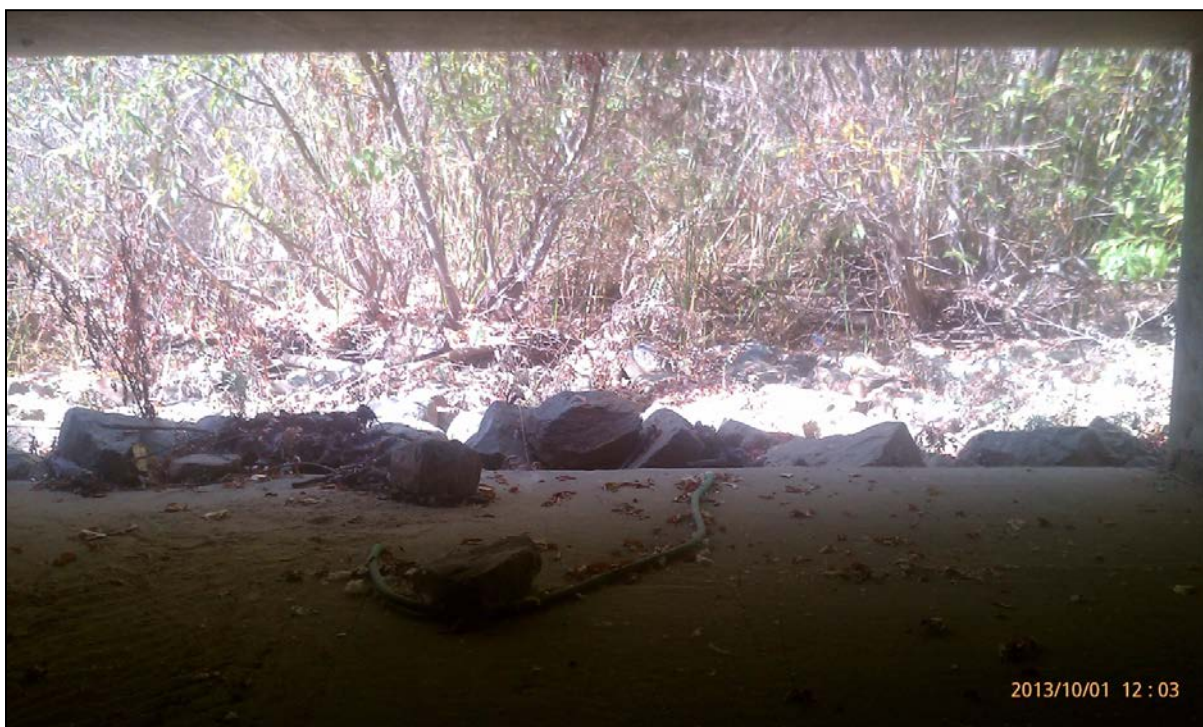
M6-1, east entrance looking east, October 2013.

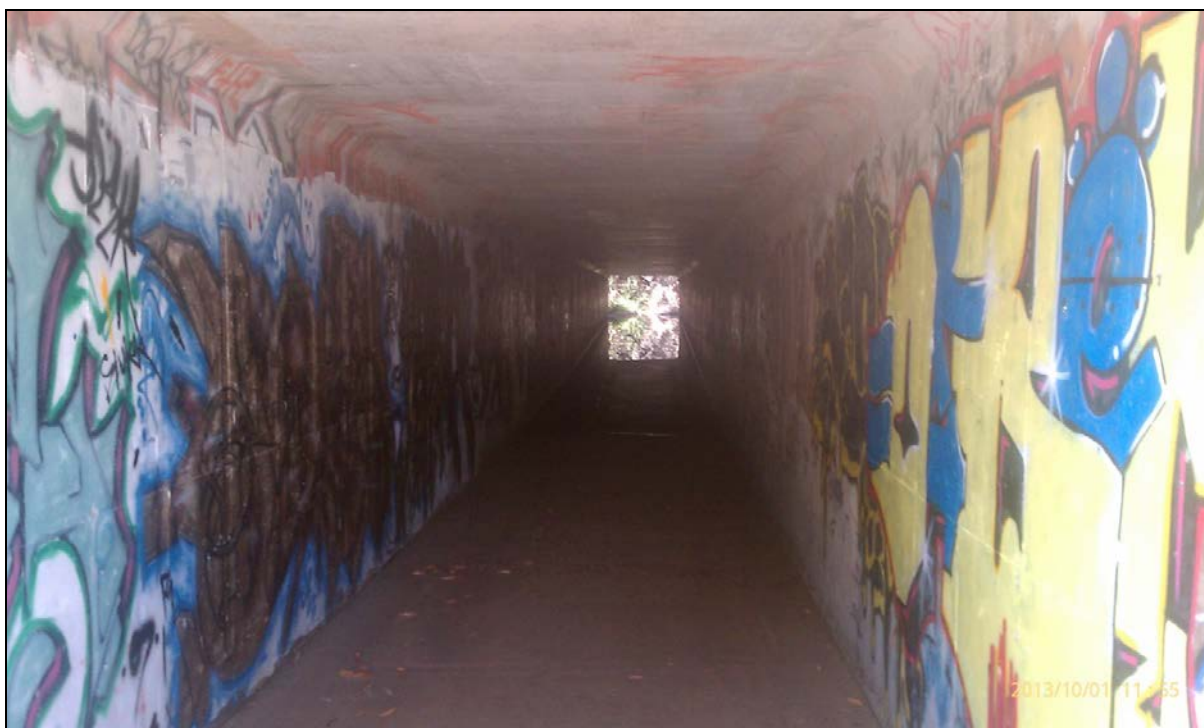
M6-2 east entrance looking west, October 2013.

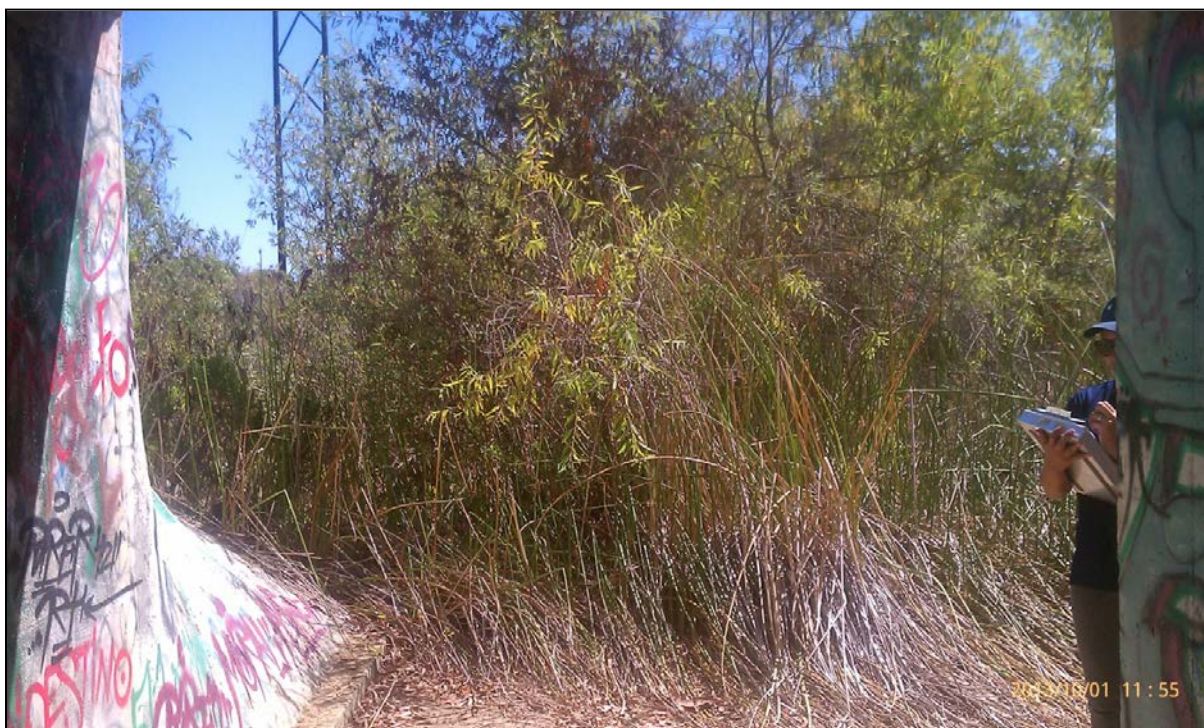
M6-2 east entrance facing east, October 2013.

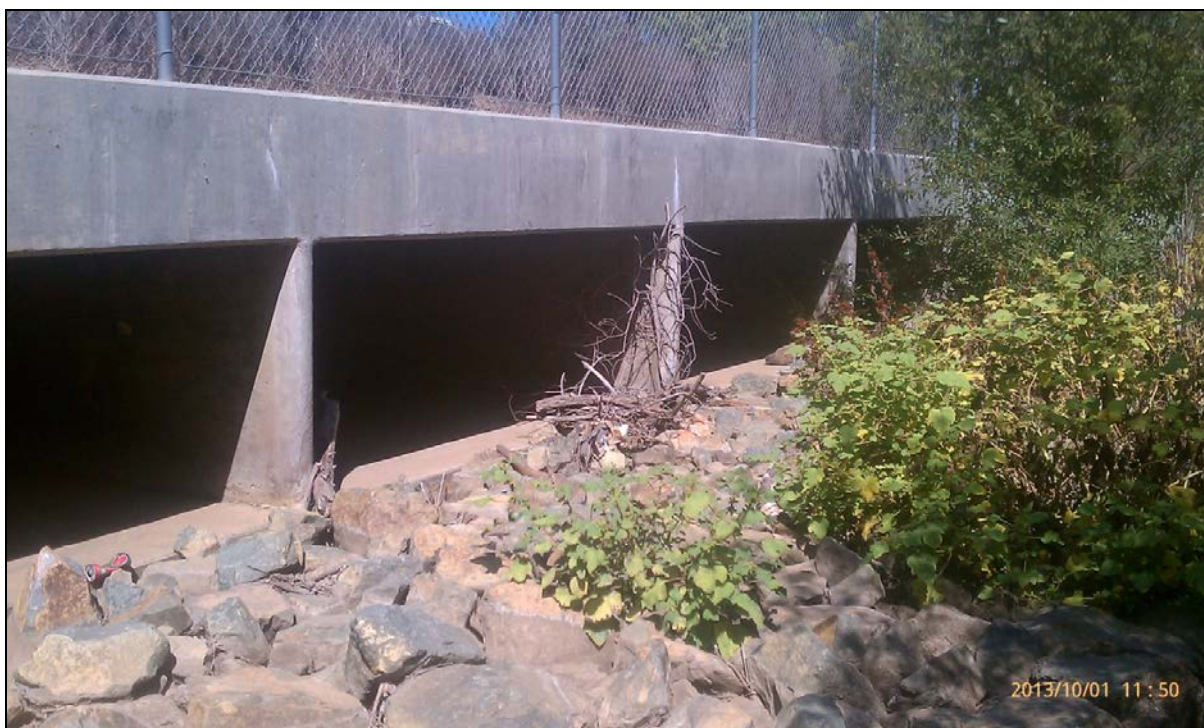
M6-3, west entrance facing southeast at multi-chambered undercrossing, October 2013.

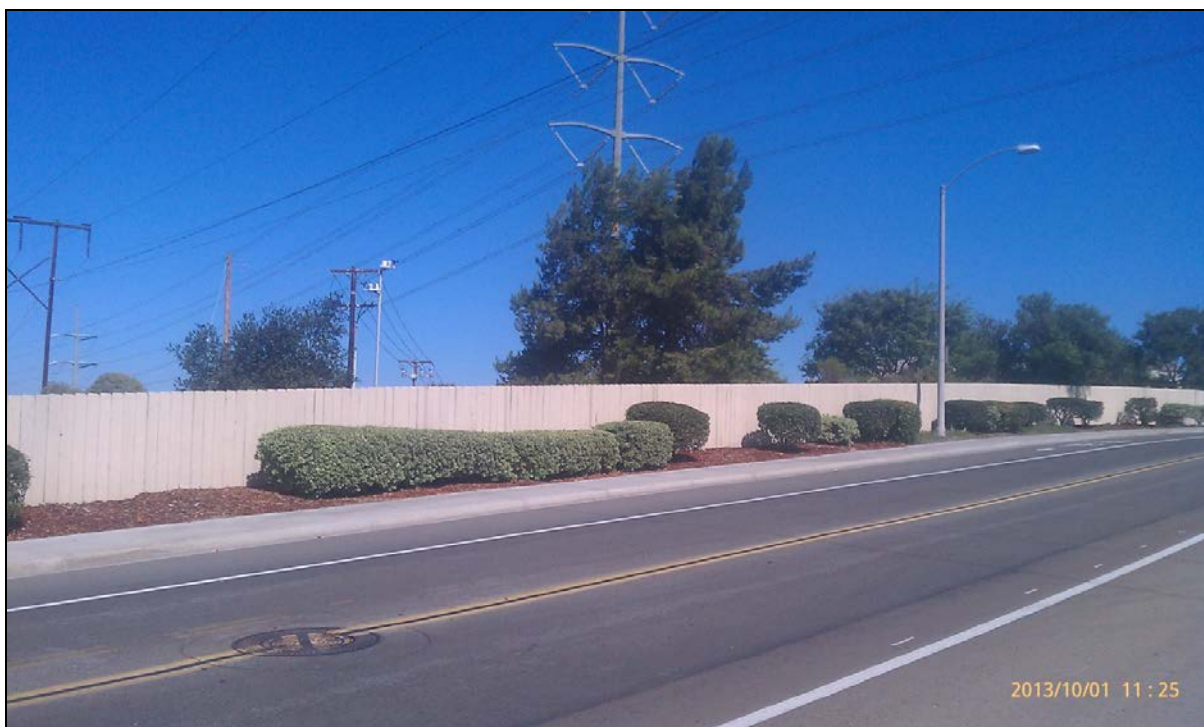
M6-4, at-grade crossing, south side, facing northeast, showing fence on north side, October 2013.

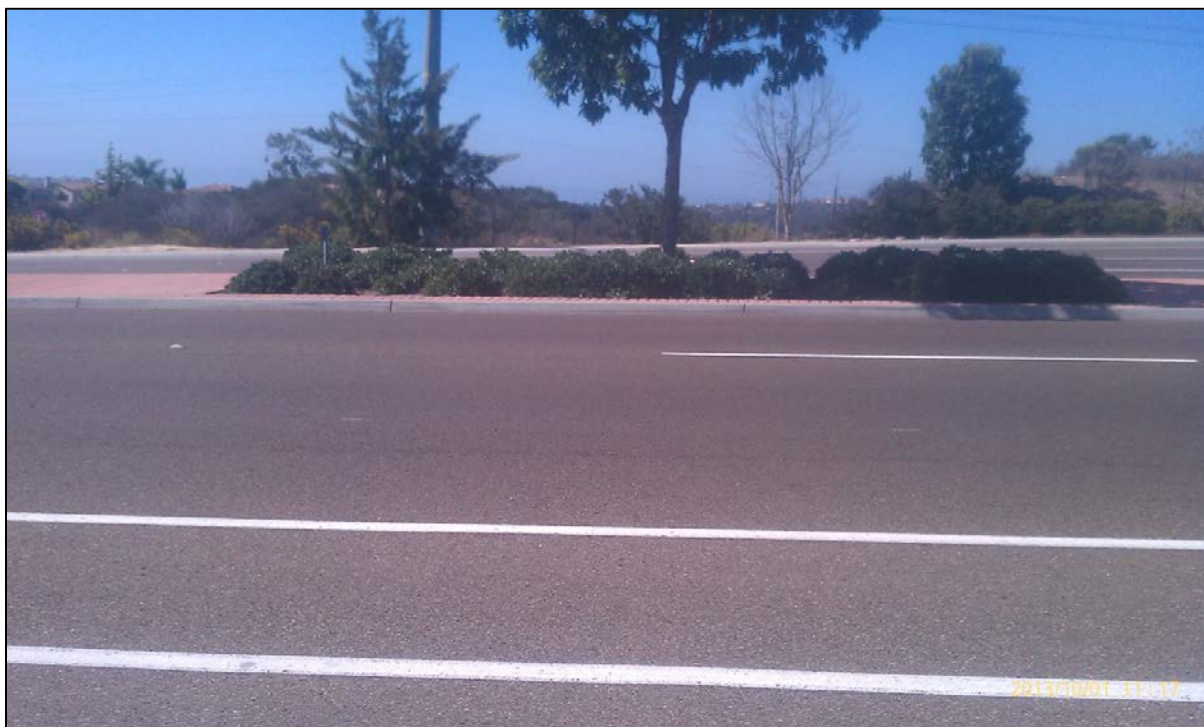
M6-5, at-grade crossing, east side looking west, October 2013

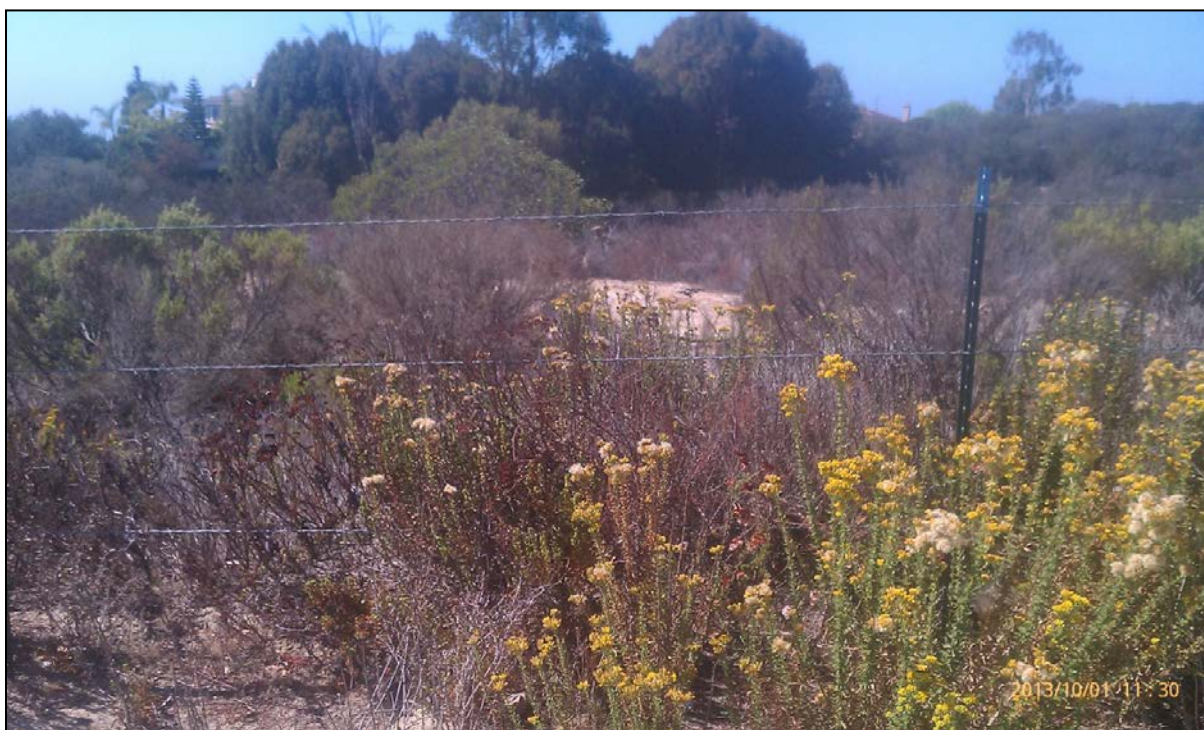
M6-5, west side facing west, showing barbed wire fencing, October 2013.

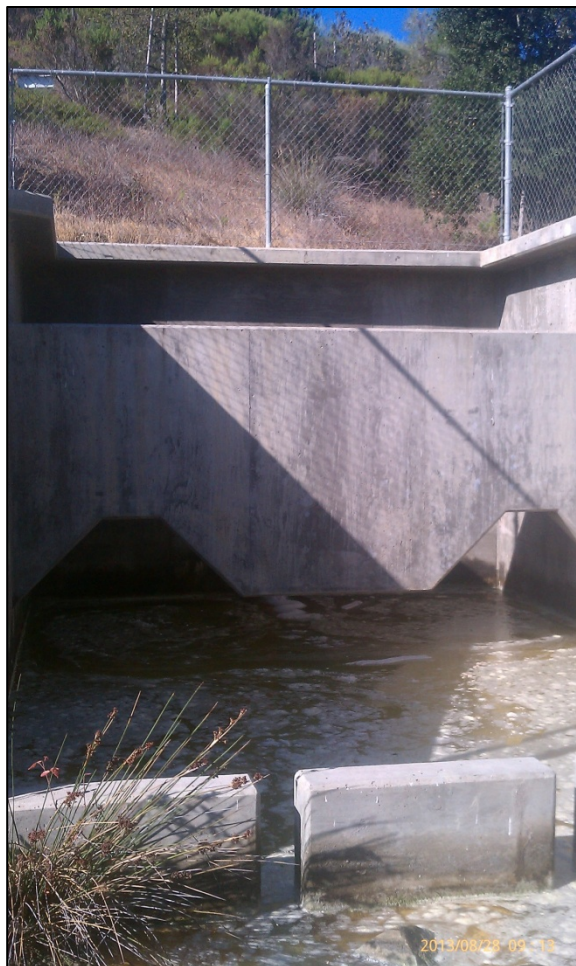
M7-1, north side showing constraints, August 2013.

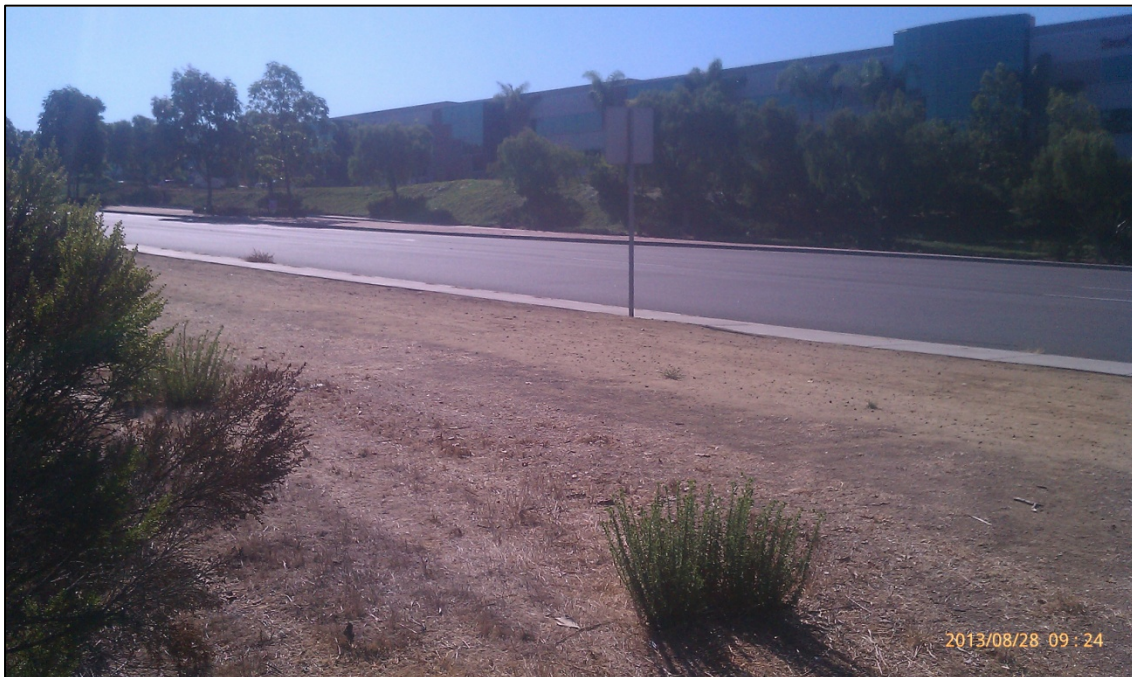
M7-2, at-grade crossing, north side facing southeast, August 2013.

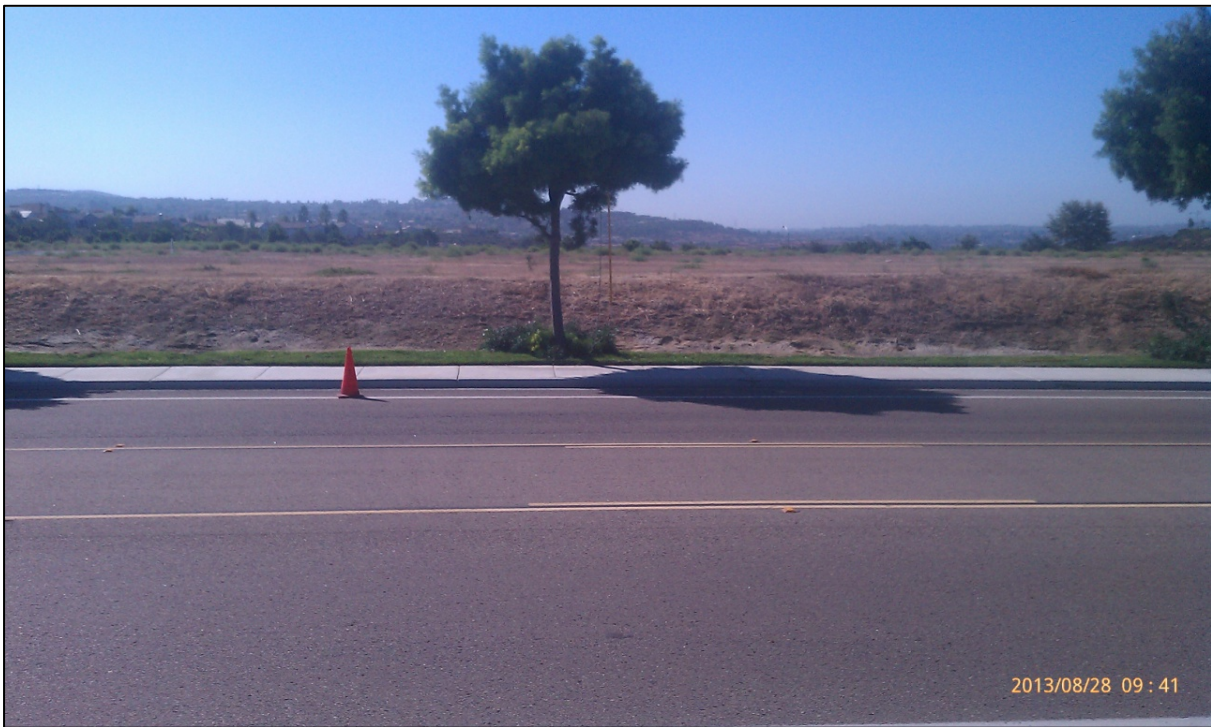
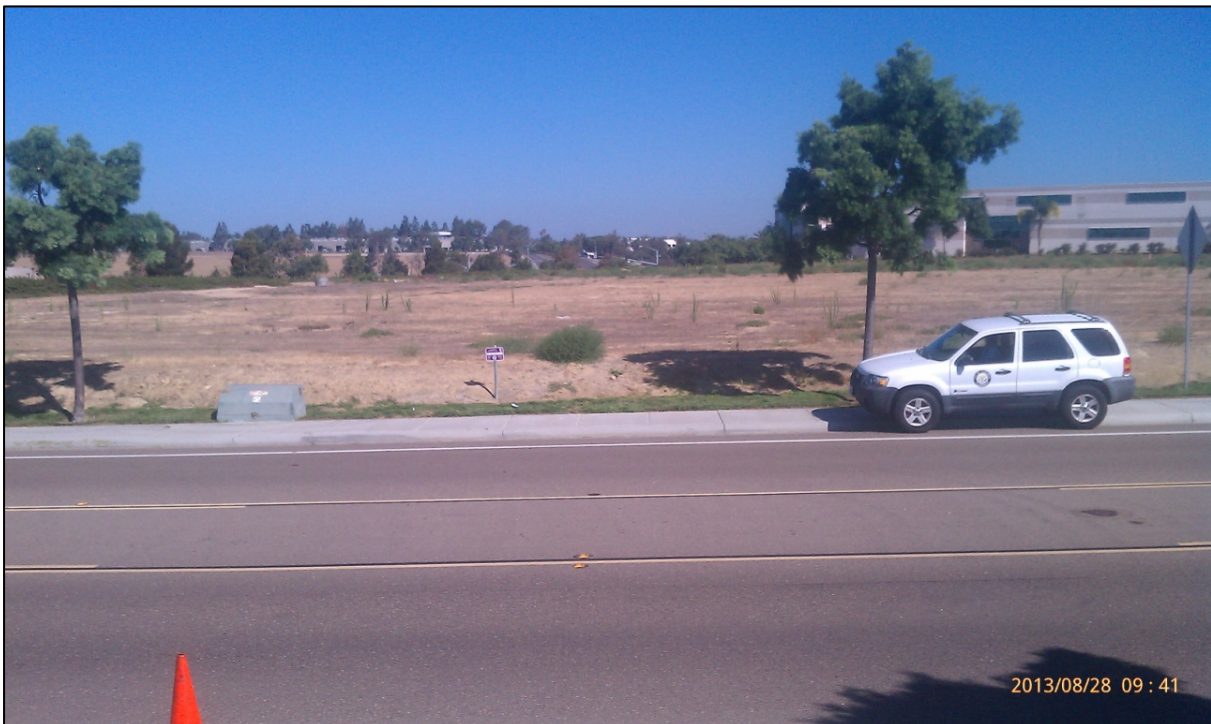
M7-3, at-grade crossing, north side facing south, August 2013.

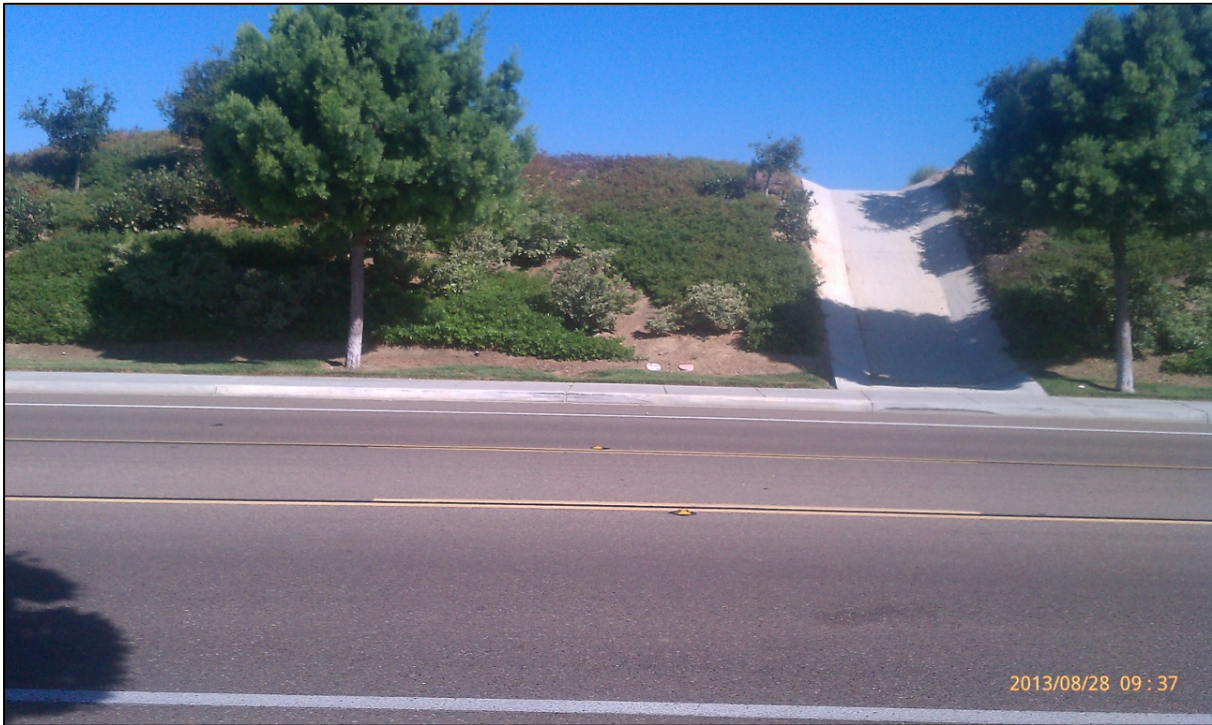
M7-4, at-grade crossing, south side looking north, August 2013

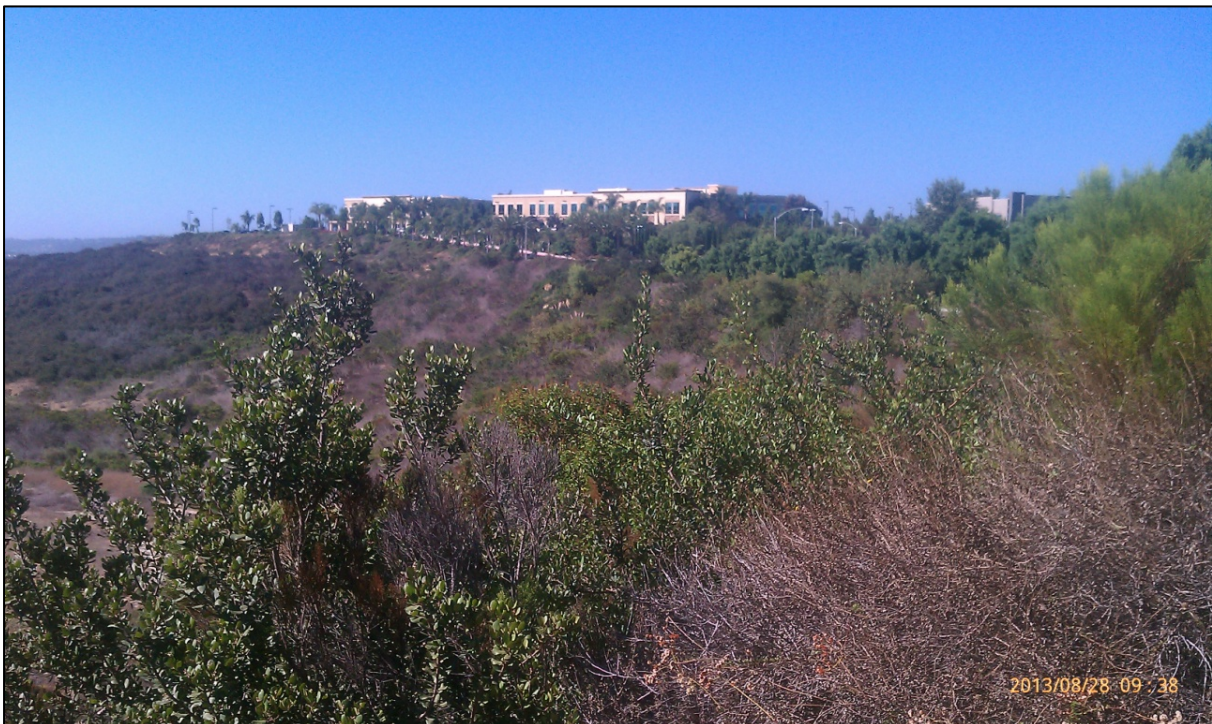
M7-4, south side facing south, August 2013.

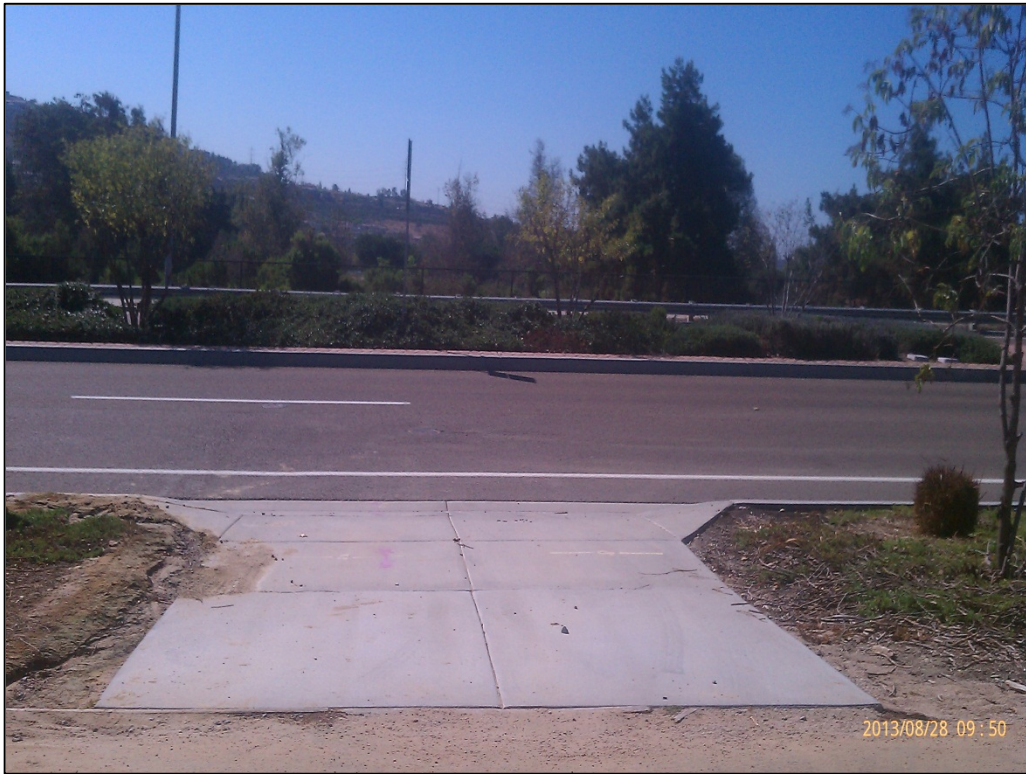
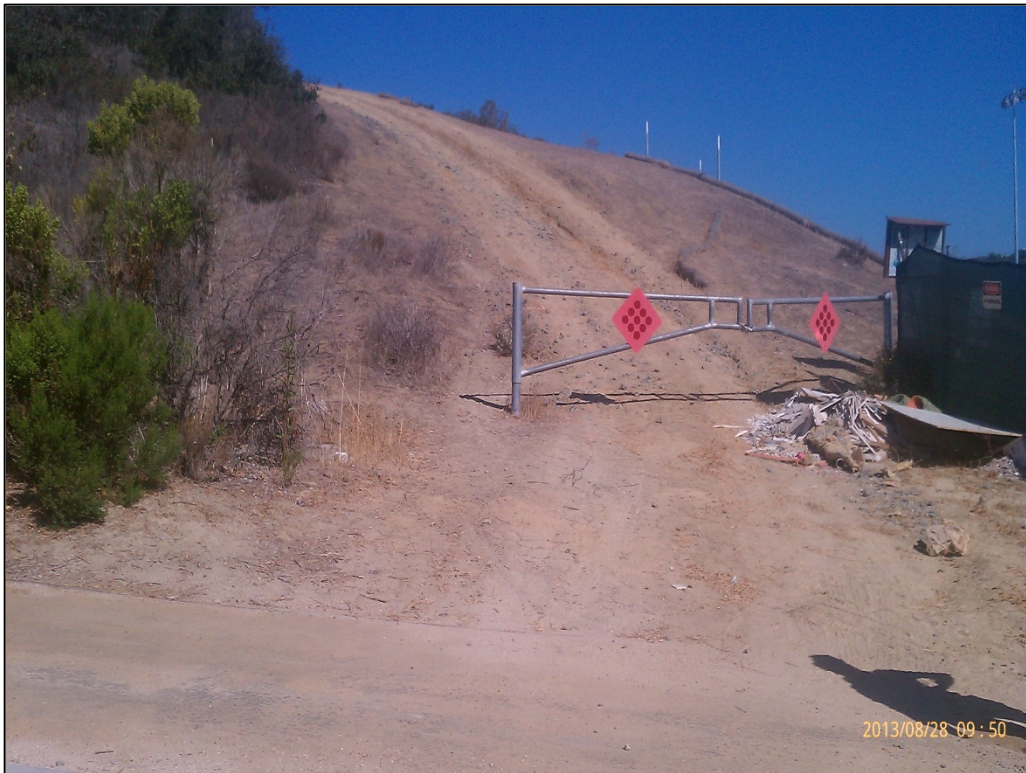
M7-5, looking south from north side, August 2013.
