# City of Carlsbad Wildlife Movement Analysis Final Report

Local Assistance Grant Agreement No.  
P1282107

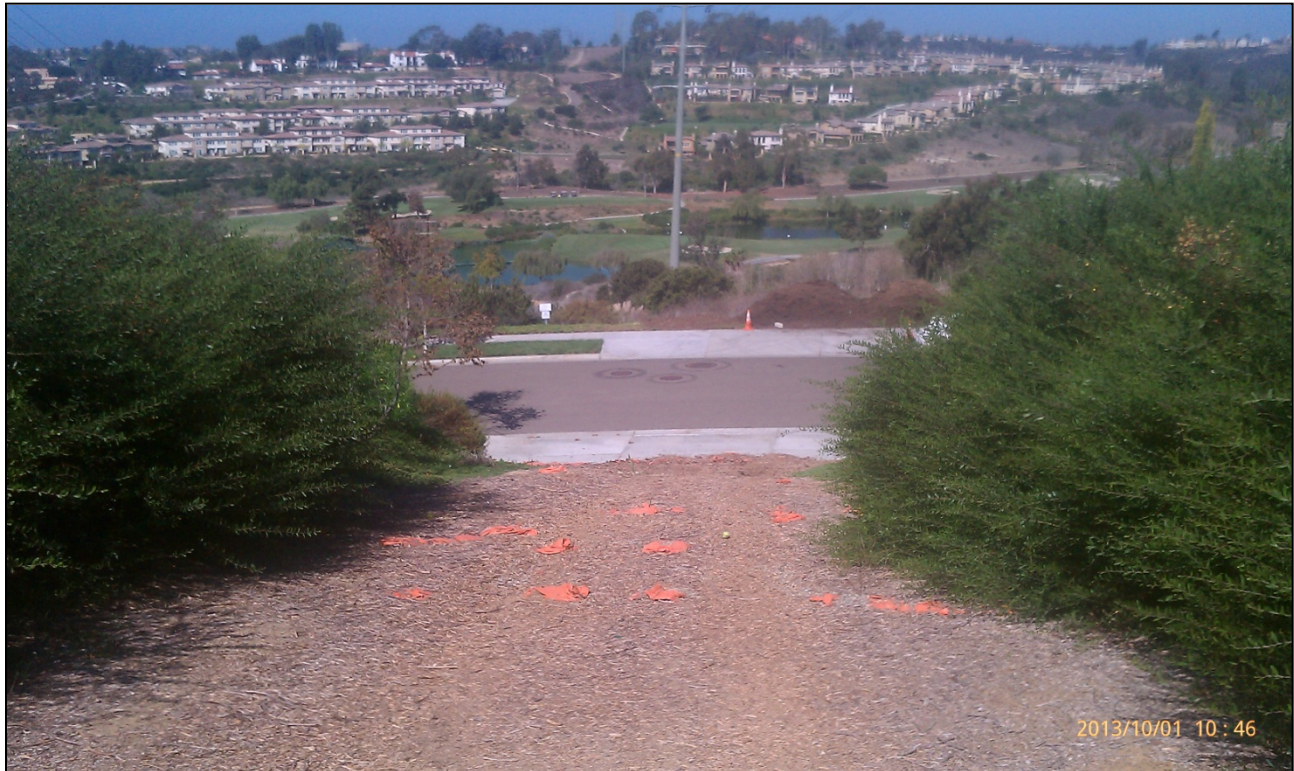
M8-1, at-grade crossing east side facing west from 40 feet away, October 2013.

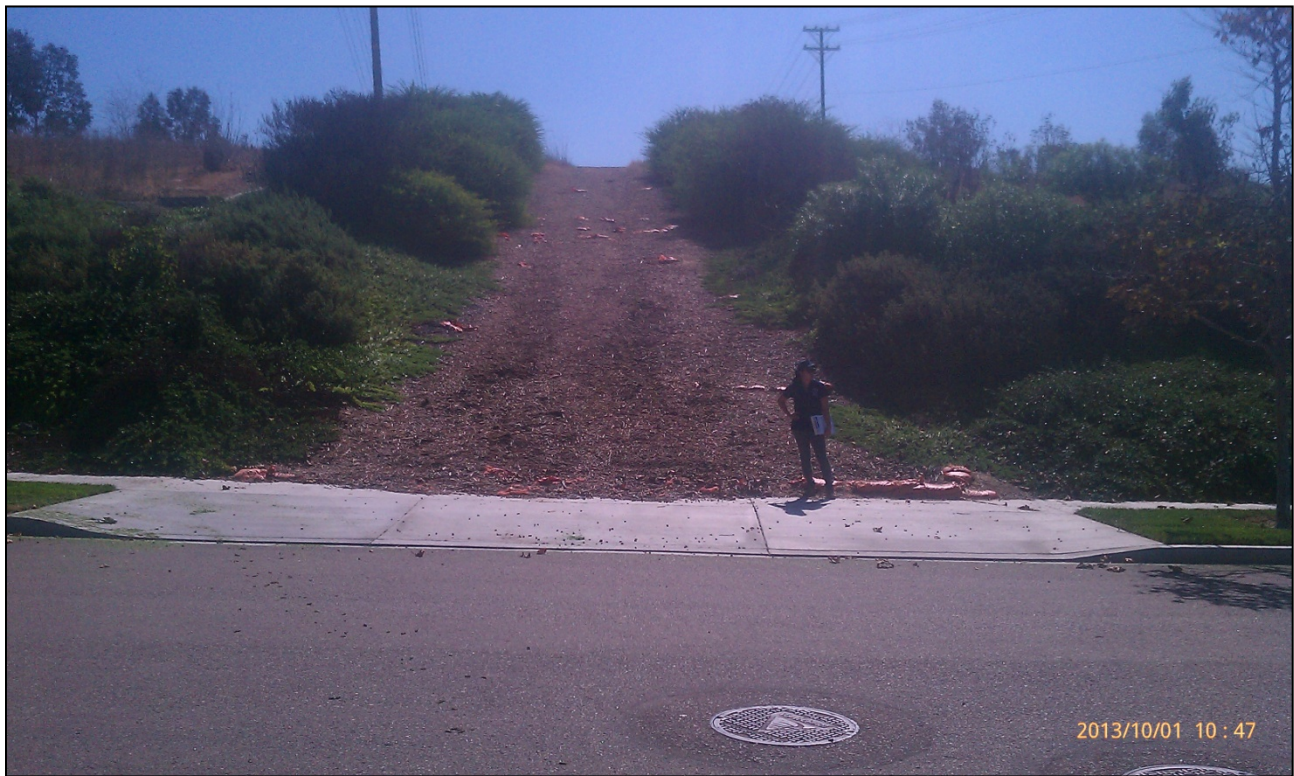
M8-1, west side looking east, October 2013.

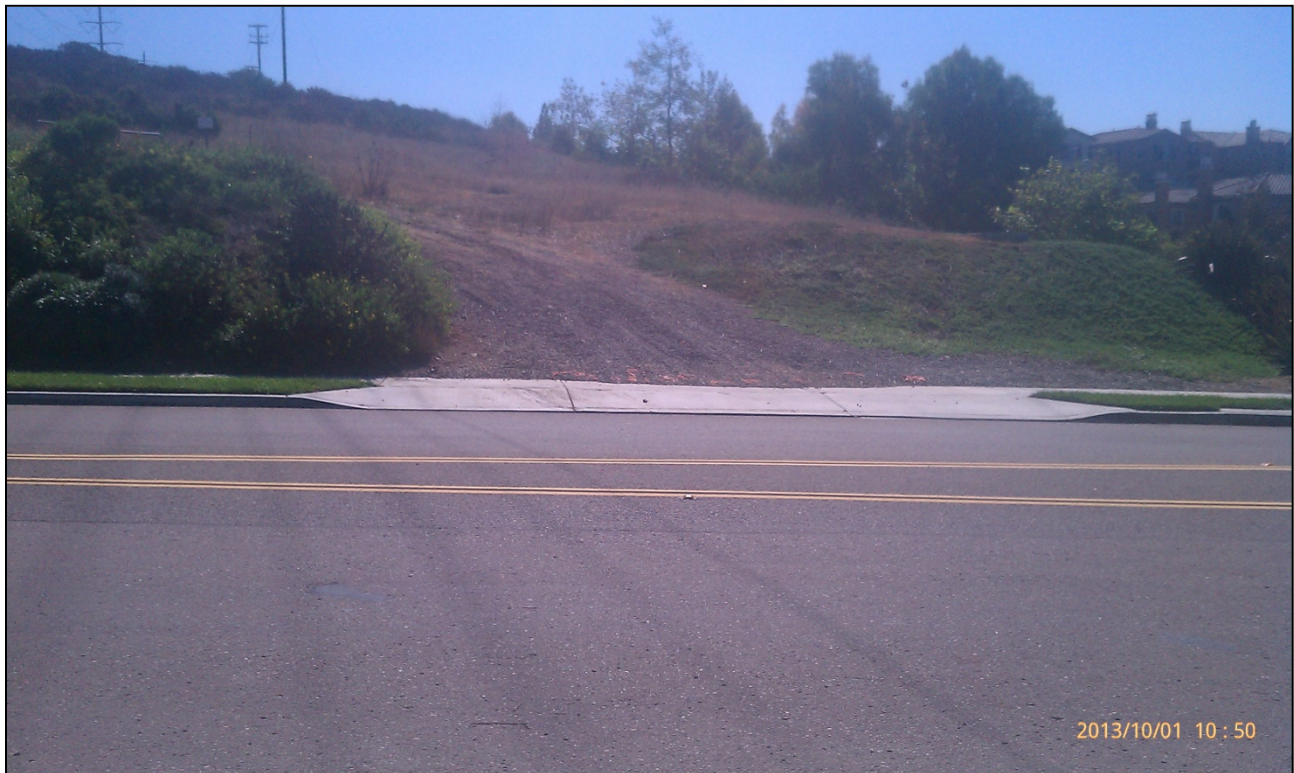
M8-2, at-grade crossing west side facing east, October 2013.

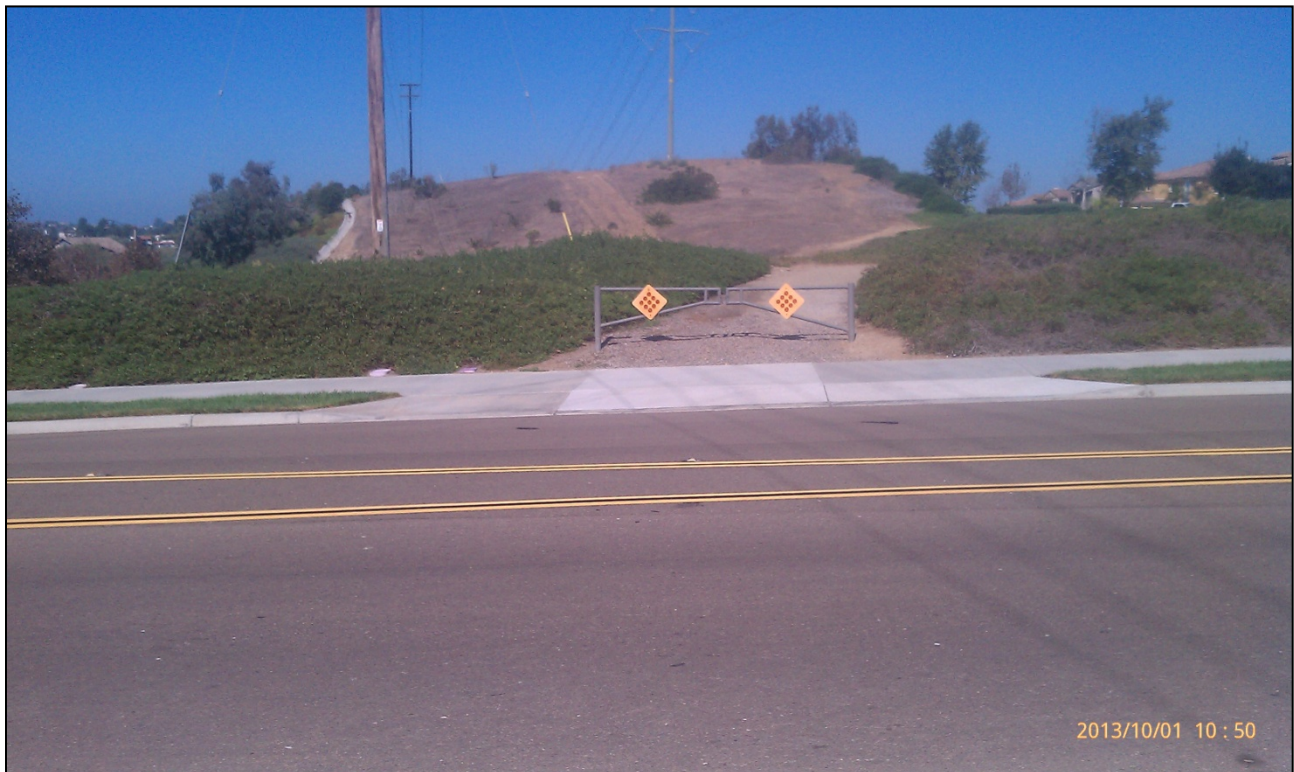
M8-2 east side looking west, October 2013.

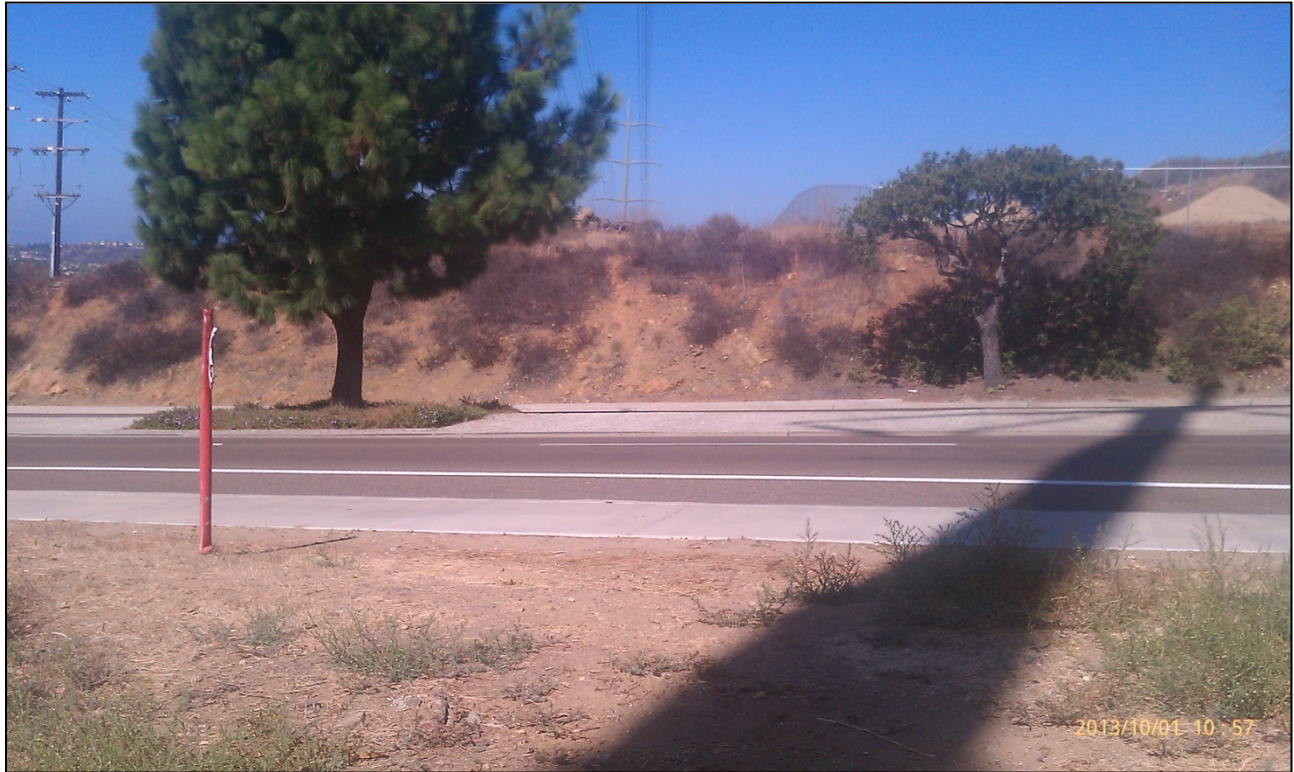
M8-3, east side looking west, October, 2013.

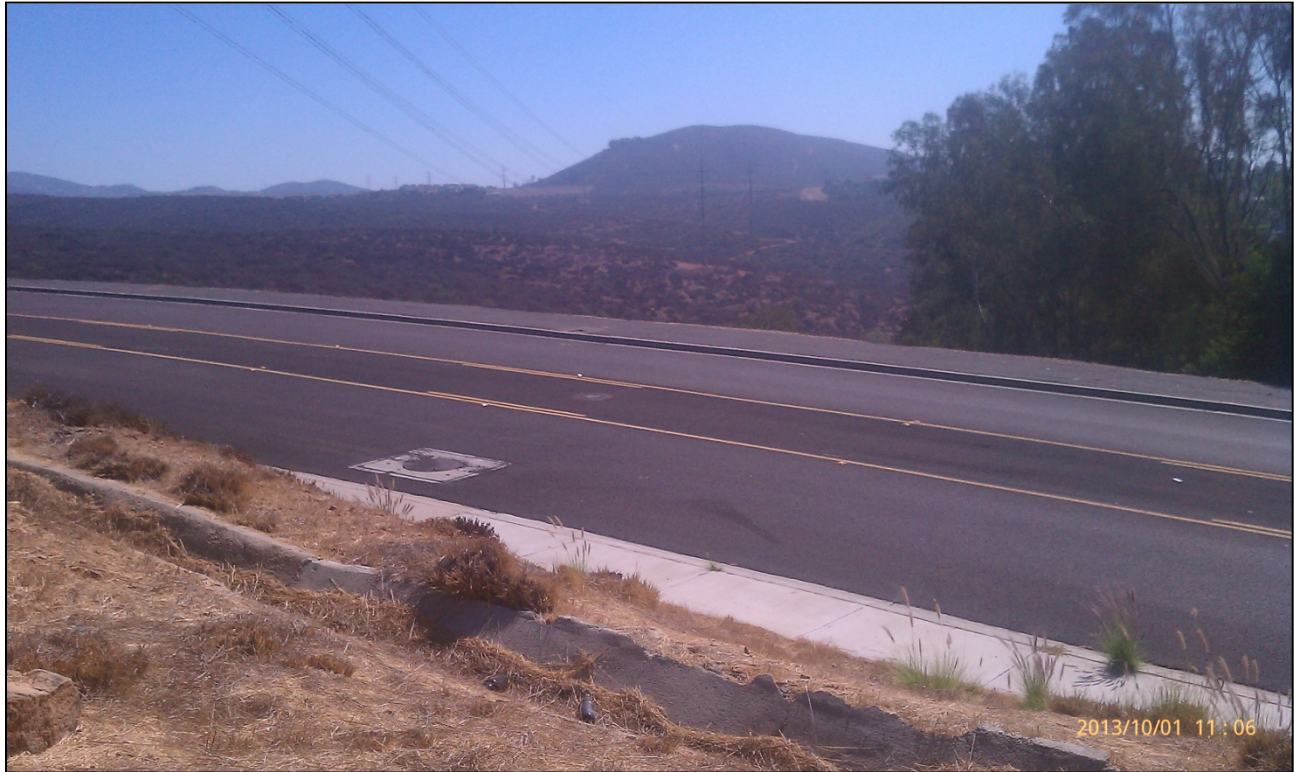
M8-4, at-grade crossing, west side looking east from top of slope, October 2013.

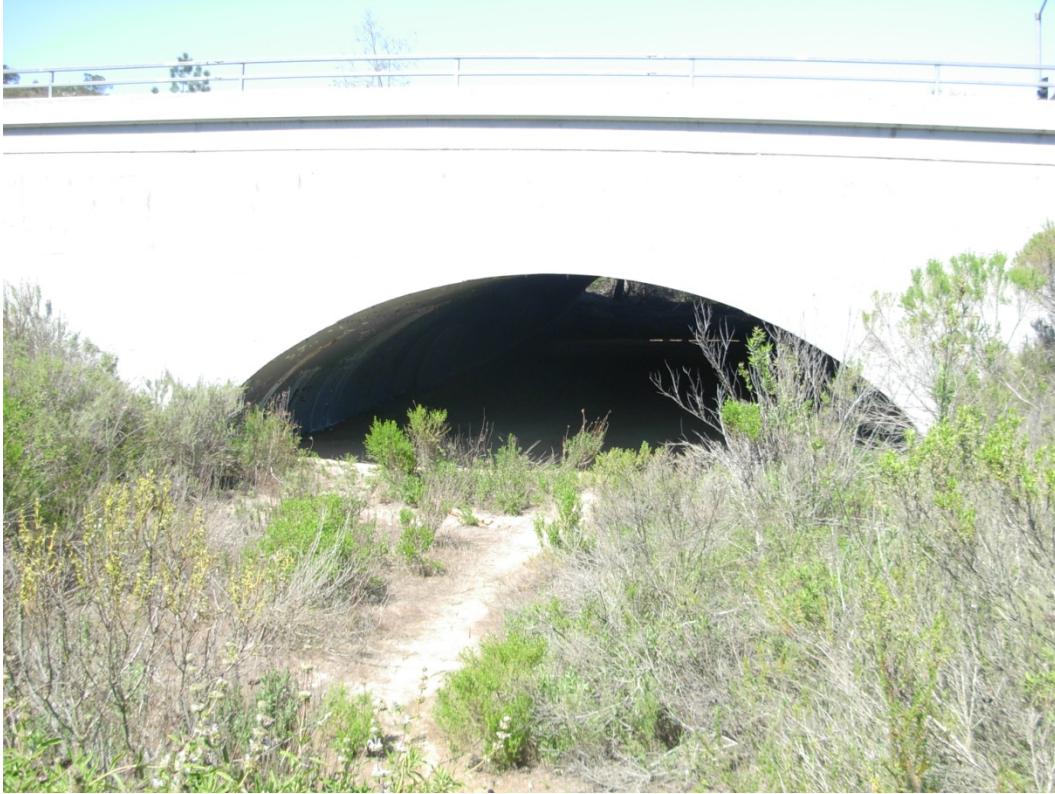
M10-1, south entrance looking north at 20 meters.

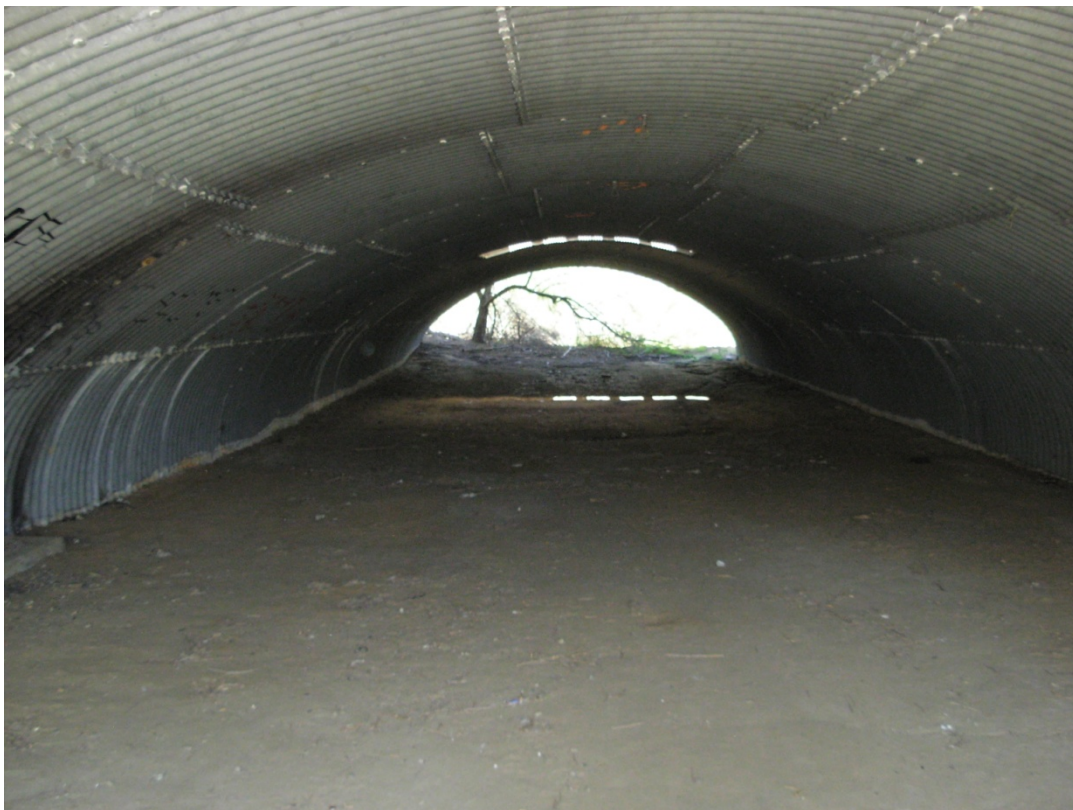
M10-1, looking north from interior.

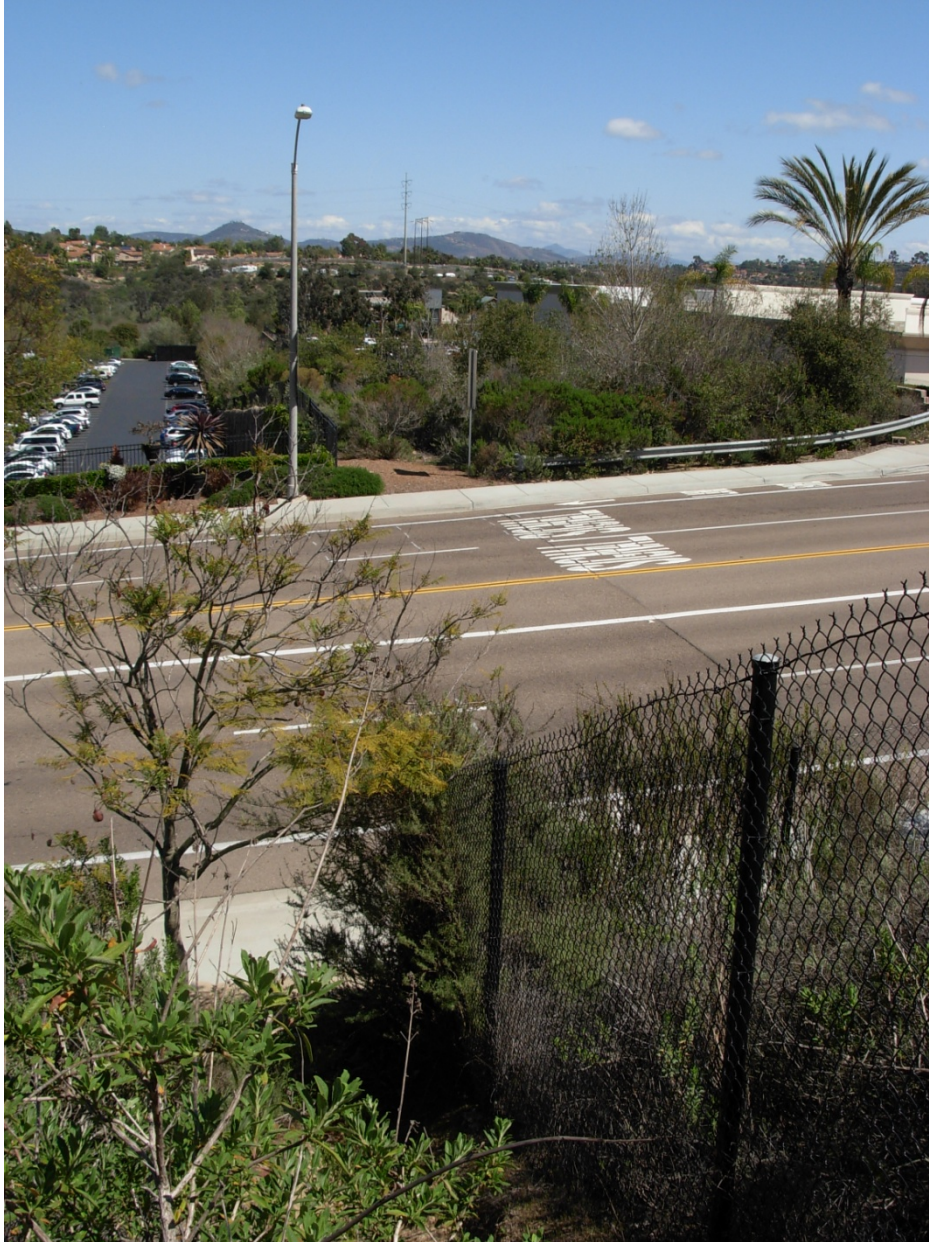
M11-1, west side looking east.

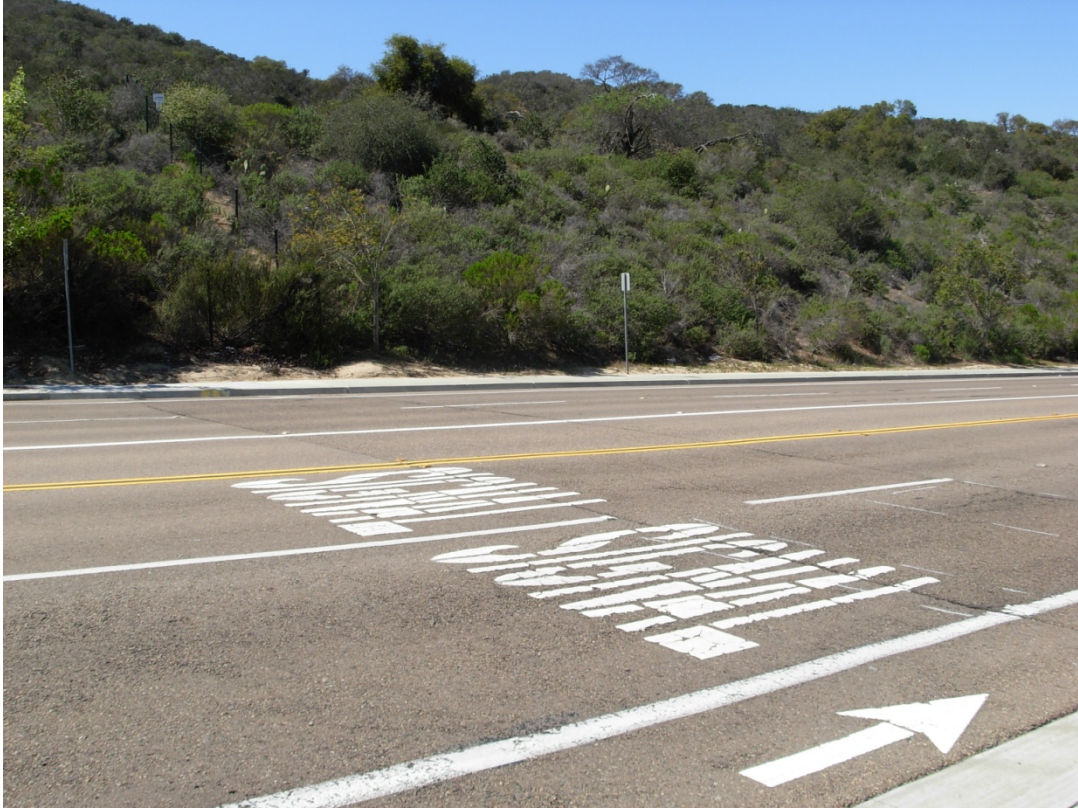
M11-1, east side looking west

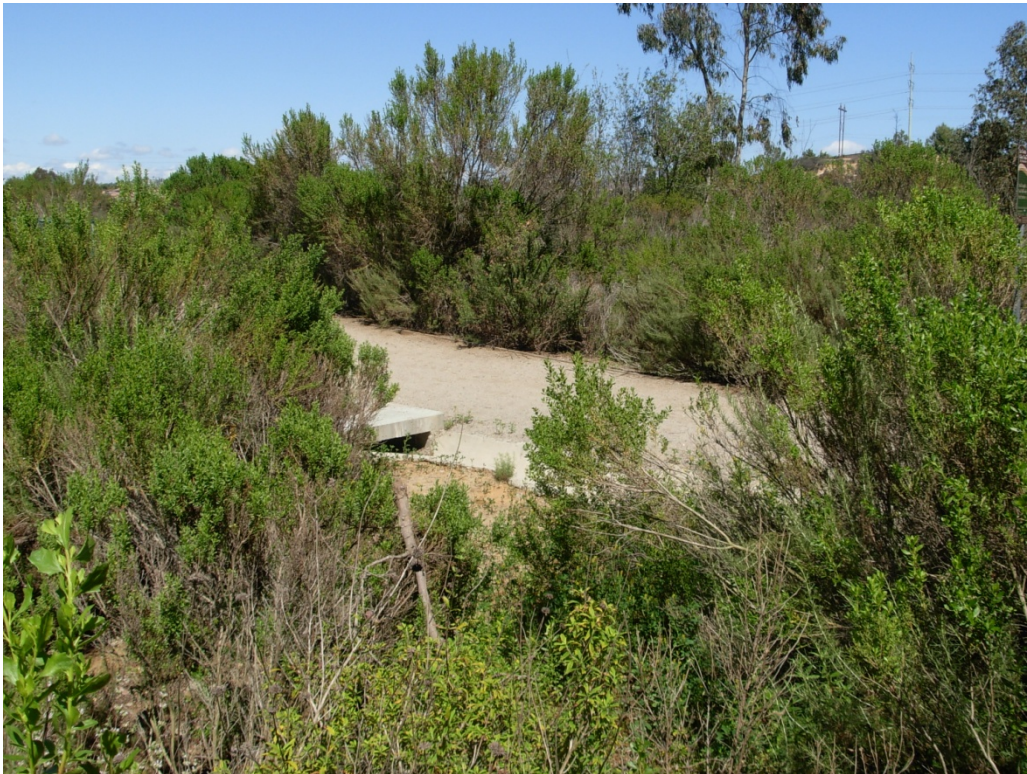
M11-2, west side looking northeast.
